# NJTPA - Local Concept Development Study Retaining Wall and Slope Stabilization Improvements Along Manhattan Avenue Union City, Hudson County, NJ

**Public Information Center (PIC) Meeting #2**  
**Monday, March 25, 2019**

EXISTING CONDITIONS REPORT  
FY 2017 HUDSON COUNTY LOCAL  
CONCEPT DEVELOPMENT STUDY  
CONTRACT "B" RETAINING WALL AND  
SLOPE STABILIZATION  
IMPROVEMENTS ALONG  
MANHATTAN AVENUE

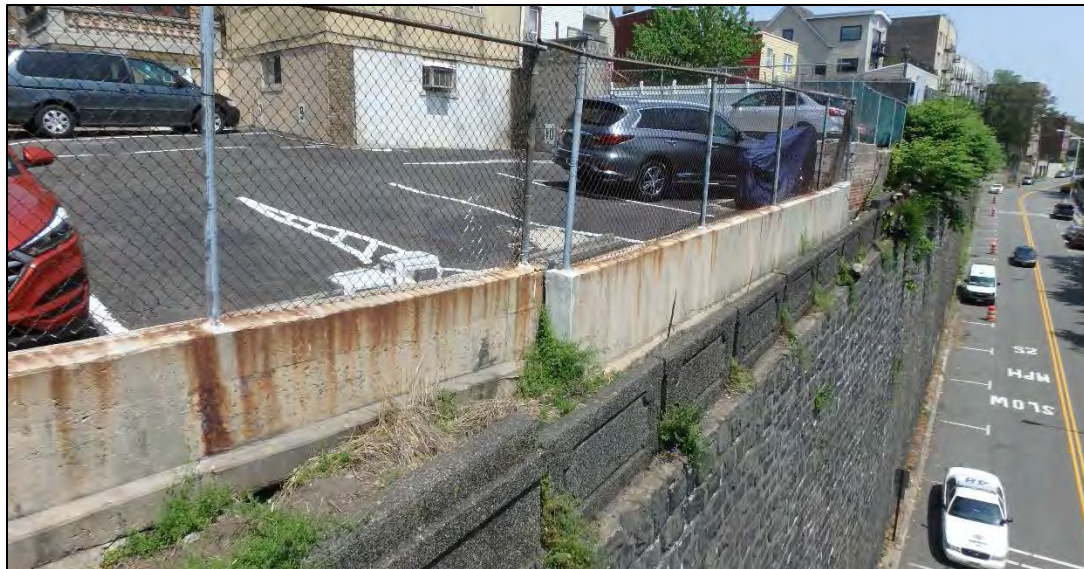
# Evaluation of Wall Deficiencies

- FPA conducted a detailed inspection of the Manhattan Avenue Retaining Walls.
  - The Overall Condition of Both Walls is POOR
    - North Wall is in worse condition
  - Vertical Cracks, Missing Mortar, and Loose Stones
  - Inadequate Drainage, Clogged Weepholes
  - Large Hollow Sounding Areas

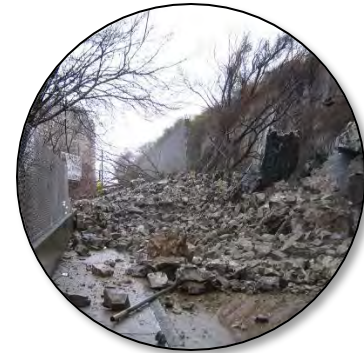
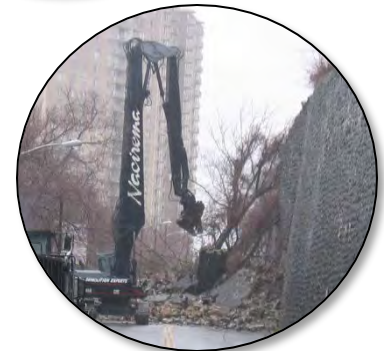
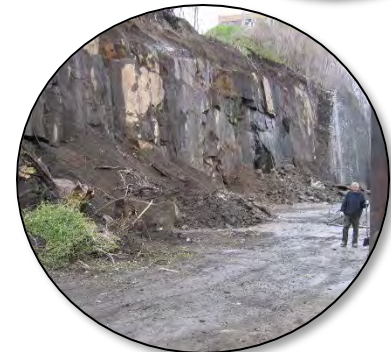
- **Modern Wall Design** – The stone masonry walls are approaching the end of their useful lives.
- **Reduced Maintenance** – Numerous resources have been invested to inspect, maintain, and repair the walls. Within the last 30 years alone, there have been at least three (3) major rehabilitation projects and other smaller-scale maintenance projects that were implemented.
- **Drainage Improvements** – Most of the weep holes appear to be clogged and not functioning.
- **Safe & Reliable Wall** – A 185-foot-long by 40-foot-high segment of the South Wall collapsed in April 2007, during a major Nor'easter.

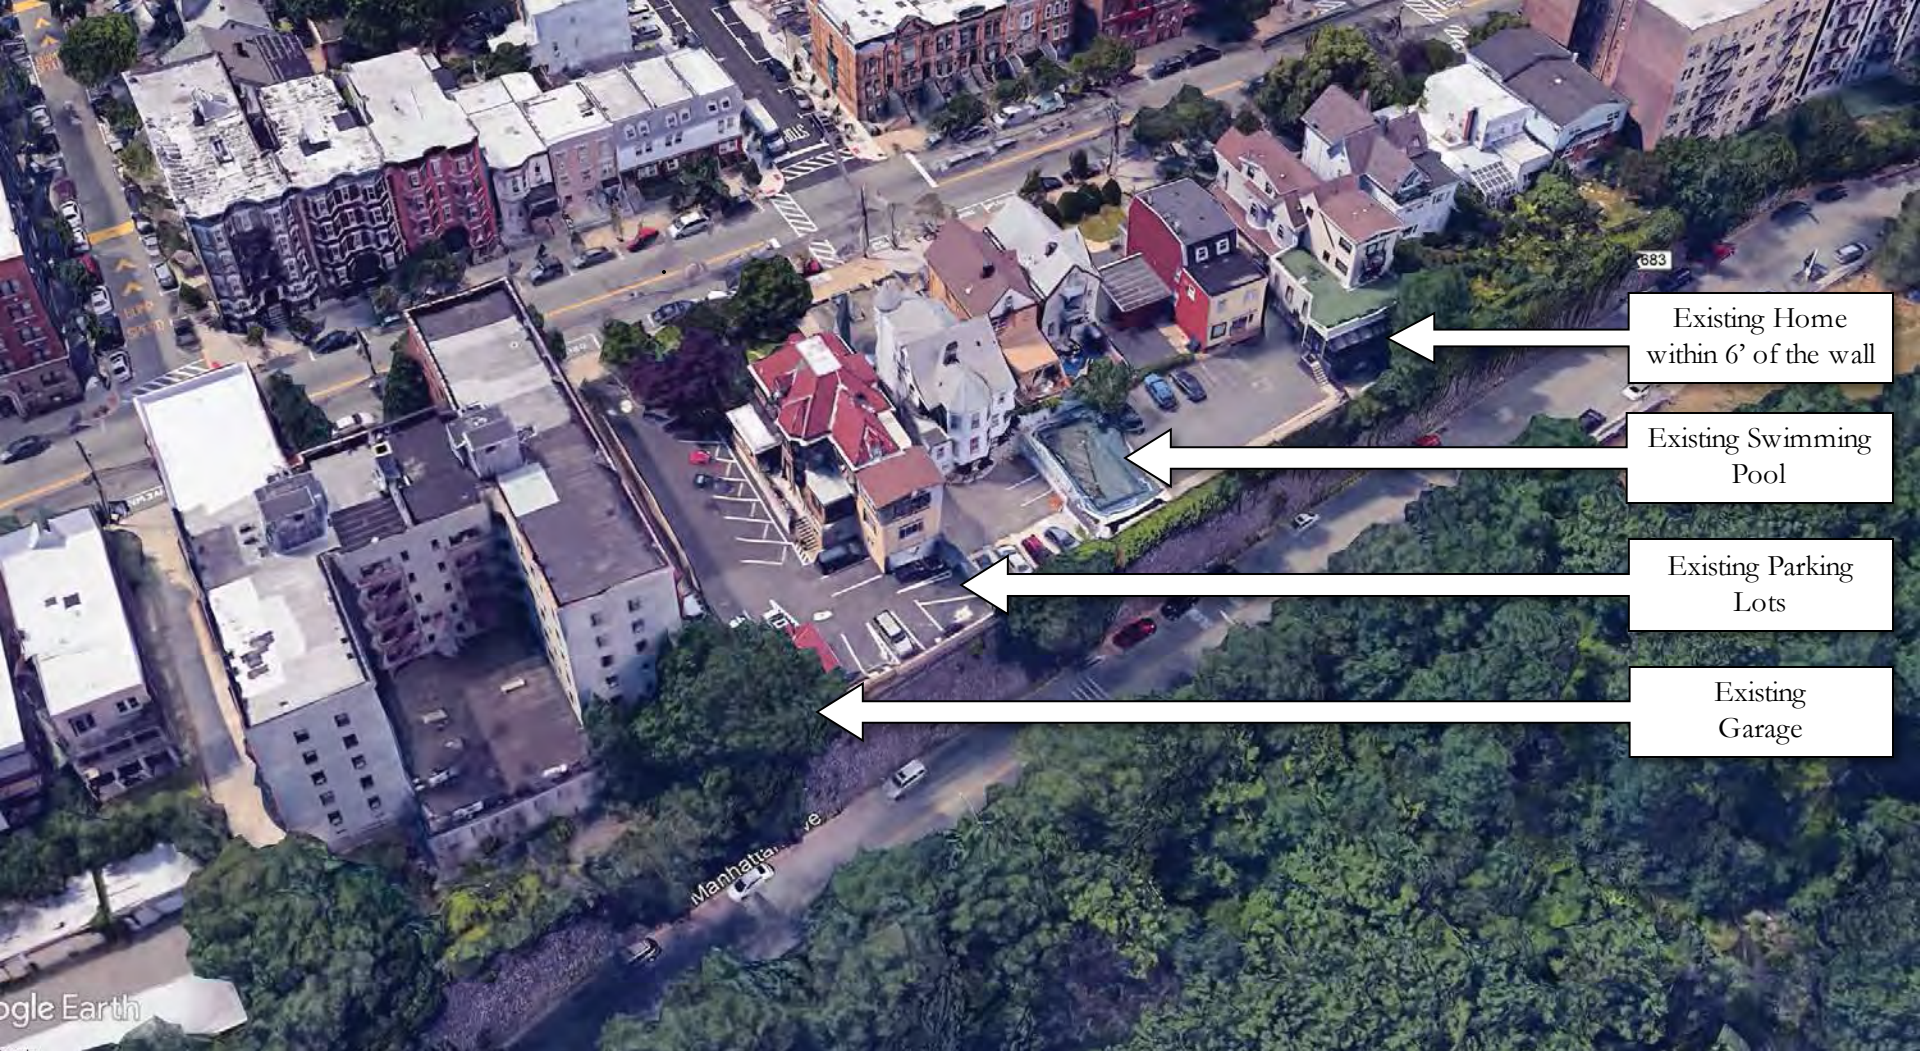
## South Wall Overview

Existing Home within 6' of the wall

Existing Swimming Pool

Existing Parking Lots

Existing Garage

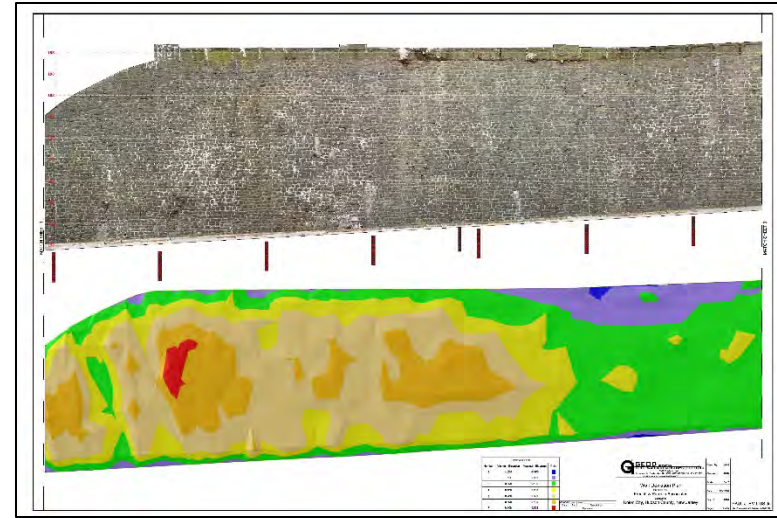
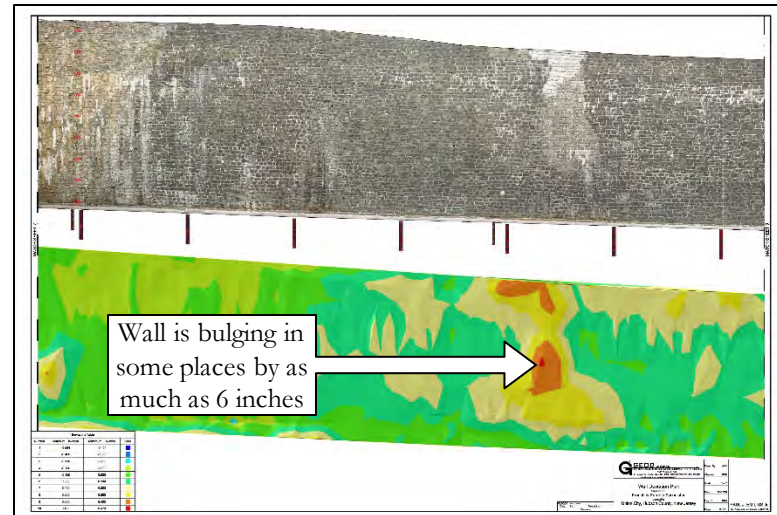
# No Build Option

- **The No-Build option does not meet the Purpose and Need.**
- The walls are approaching the end of their useful lives.
- Many of the previous wall repairs have not held up.
  - Bulging, leaking, missing mortar and hollow sounding areas.
- As the wall continues to age, the rate of deterioration will likely increase.

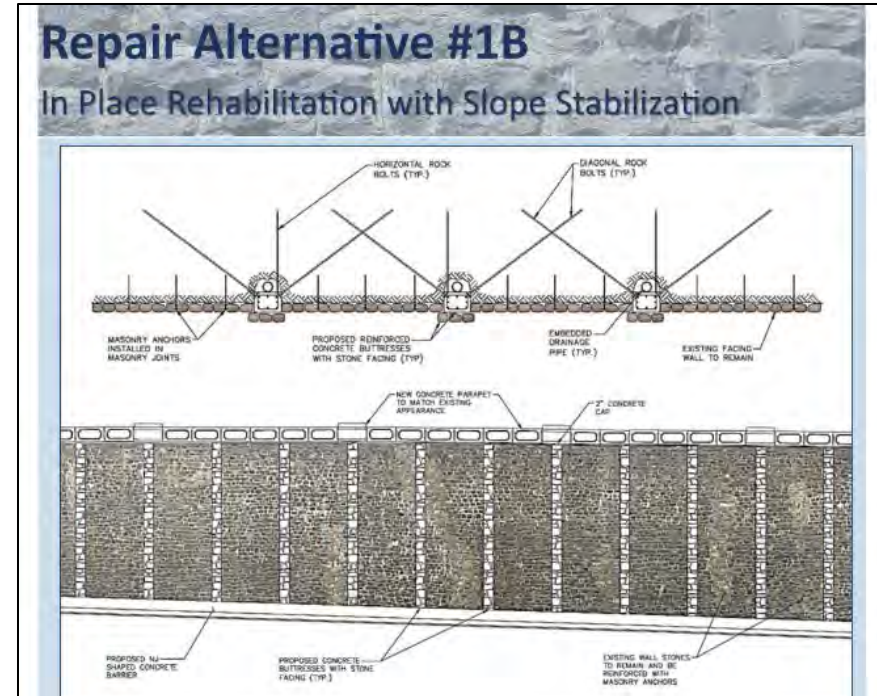
# Rehabilitation Options – Alternative #1B

- Alternative #1B is similar to #1A, but provides limited slope stabilization and isolated drainage improvements.
  - Rehabilitation is not a viable alternative
    - Due to the many unknown risks associated with the location and nature of the rock face.
    - May ultimately require the removal of the entire wall to facilitate the repairs.

• **Alternative #1B does not meet the Project Purpose & Need.**

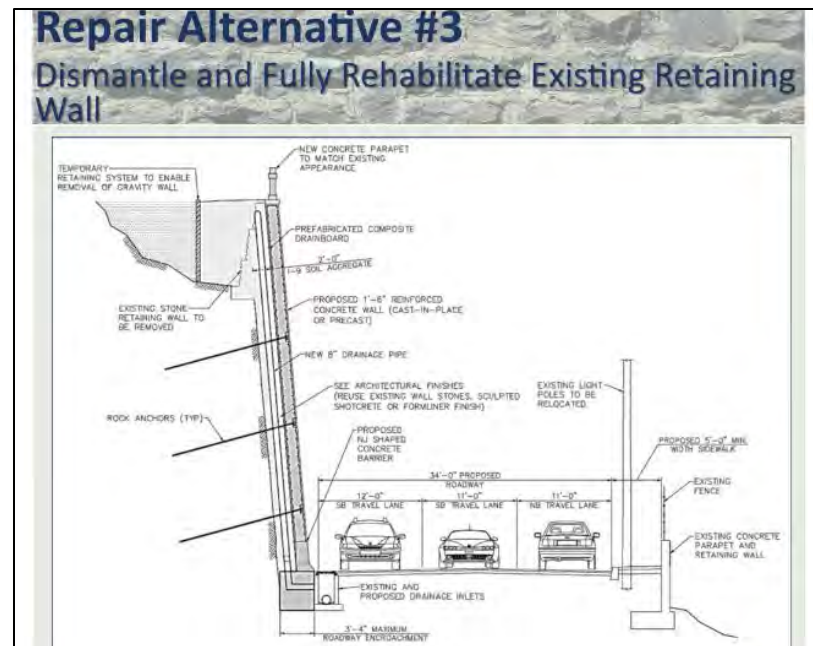
# Reconstruction Options – Alternative #3

- Alternative #3 removes the existing wall and replaces it with a new modern wall.

- Similar to Alternative #2, and provides drainage and slope stabilization.
- Permits reuse of original stone.
- Reduces impact to Manhattan Avenue Roadway alignment.
- Removes unknown risks associated with the condition of the rock face.
- Results in significant impacts to properties along top of wall.
- Requires temporary retaining system.

- **Alternative #3 meets the Purpose and Need and is best for the South Wall.**

- Option #3A: Widen roadway
  - Recommended
- Option #3B: Reduce roadway

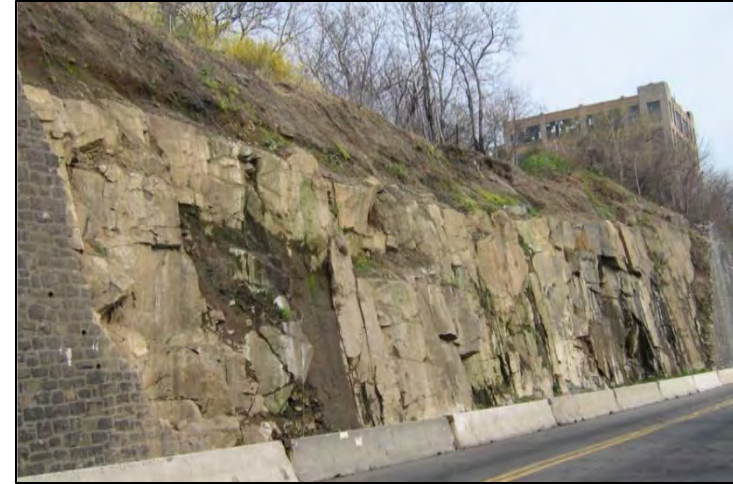
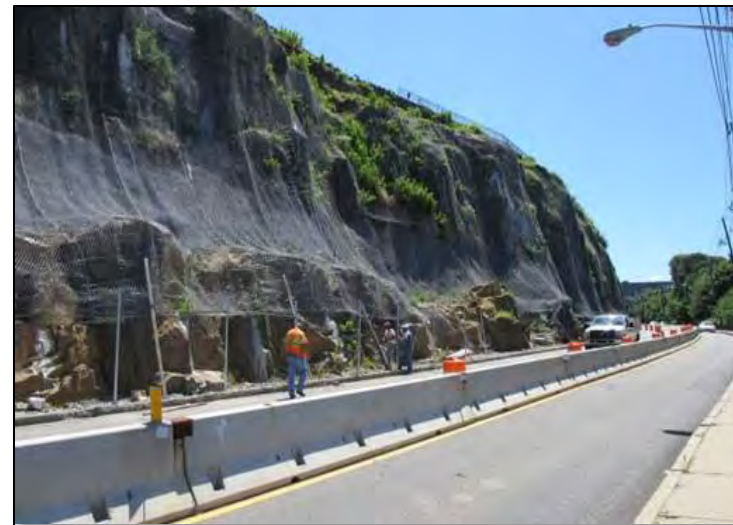
# Demolition Option - Alternative #4

- Alternative #4 includes the removal of the existing stone masonry façade and gravity wall and exposes the Palisade rock face.
  - Reduce maintenance by removal of stone masonry.
  - Eliminates need for drainage improvements, however slope stability is still required.
  - Aesthetically unpleasing.
  - Will likely require a rock catchment system to prevent loose rocks from falling on the roadway.
  - Severe impacts to properties adjacent to the wall.
    - Eliminates an historic cultural resource.
- **Alternative #4 does not meet the Project Purpose & Need.**

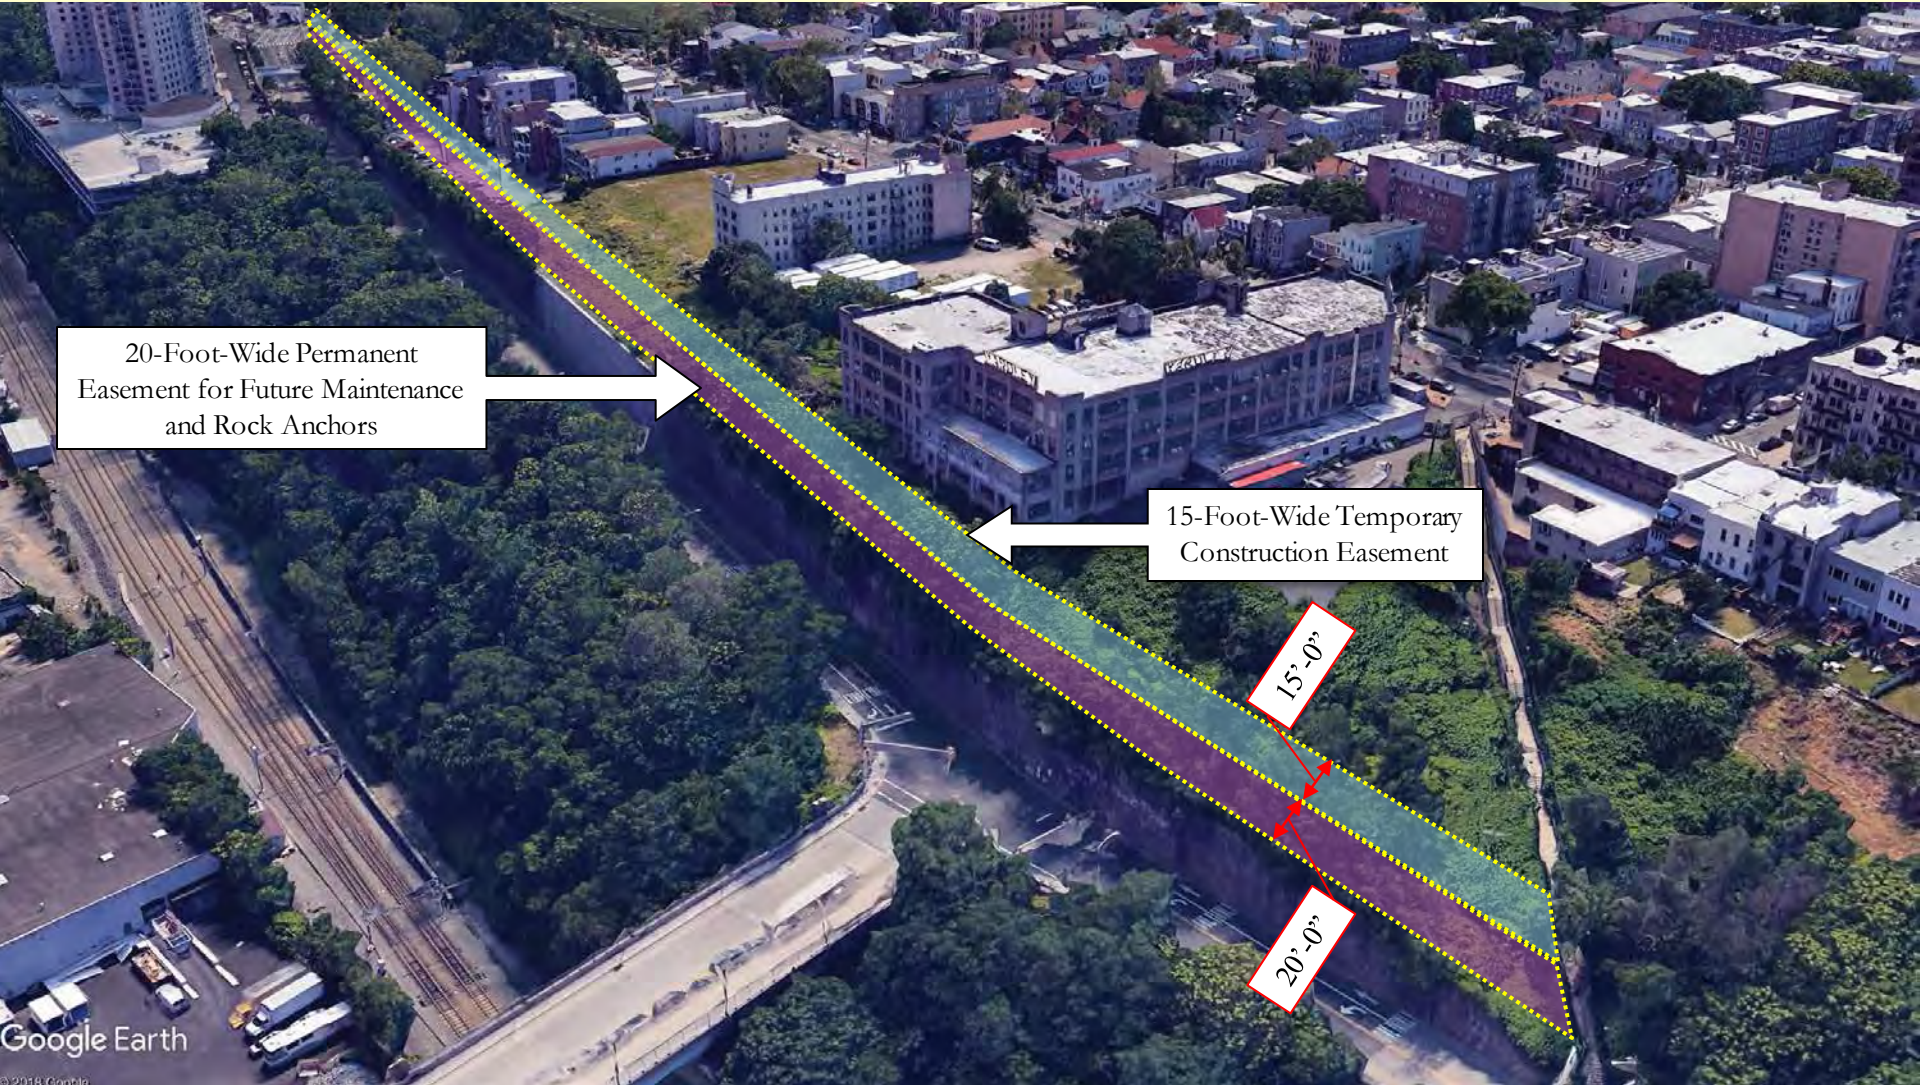
# Anticipated Access Easements - South Wall

20-Foot-Wide Permanent Easement for Future Maintenance and Rock Anchors

15-Foot-Wide Temporary Construction Easement
