FY 2017 Hudson, Morris, & Somerset Counties Local Concept Development Studies Contract "B"

Retaining Wall & Slope Stabilization Improvements Along Manhattan Avenue

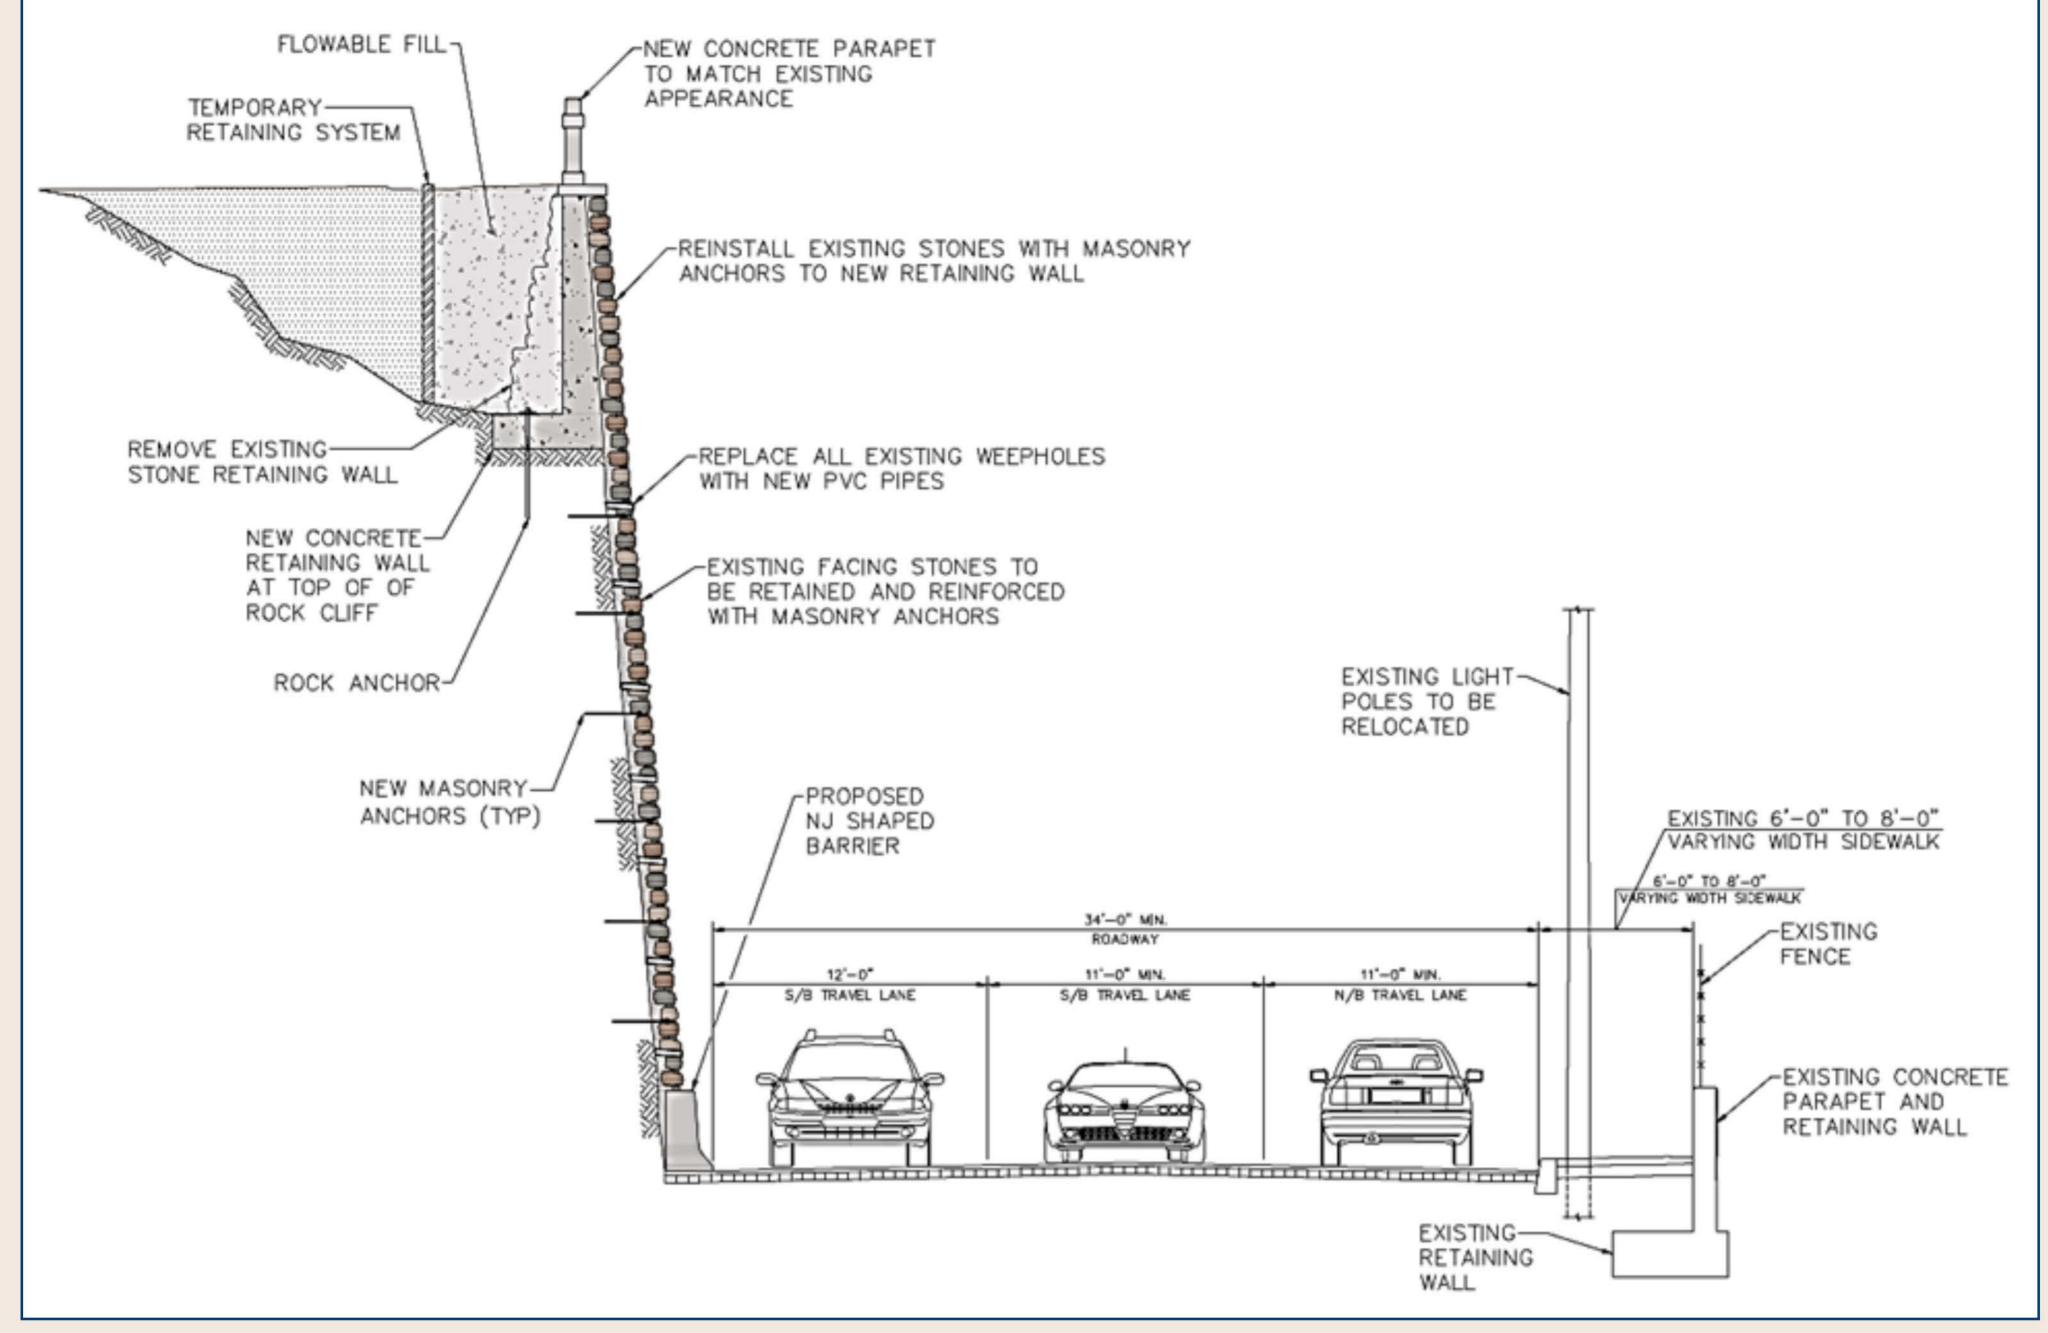
Repair Alternative #1A

In Place Rehabilitation Without Slope Stabilization

- Eliminates need for wall demolition.
- Significantly lower cost than other repair alternatives.
- Can be developed in a manner that

- Does not improve mismatched appearance of the previous various wall repairs.
- Does not enable installation of new

drainage enhanced system behind wall. New weepholes will be provided but they may get clogged over time and will require regular

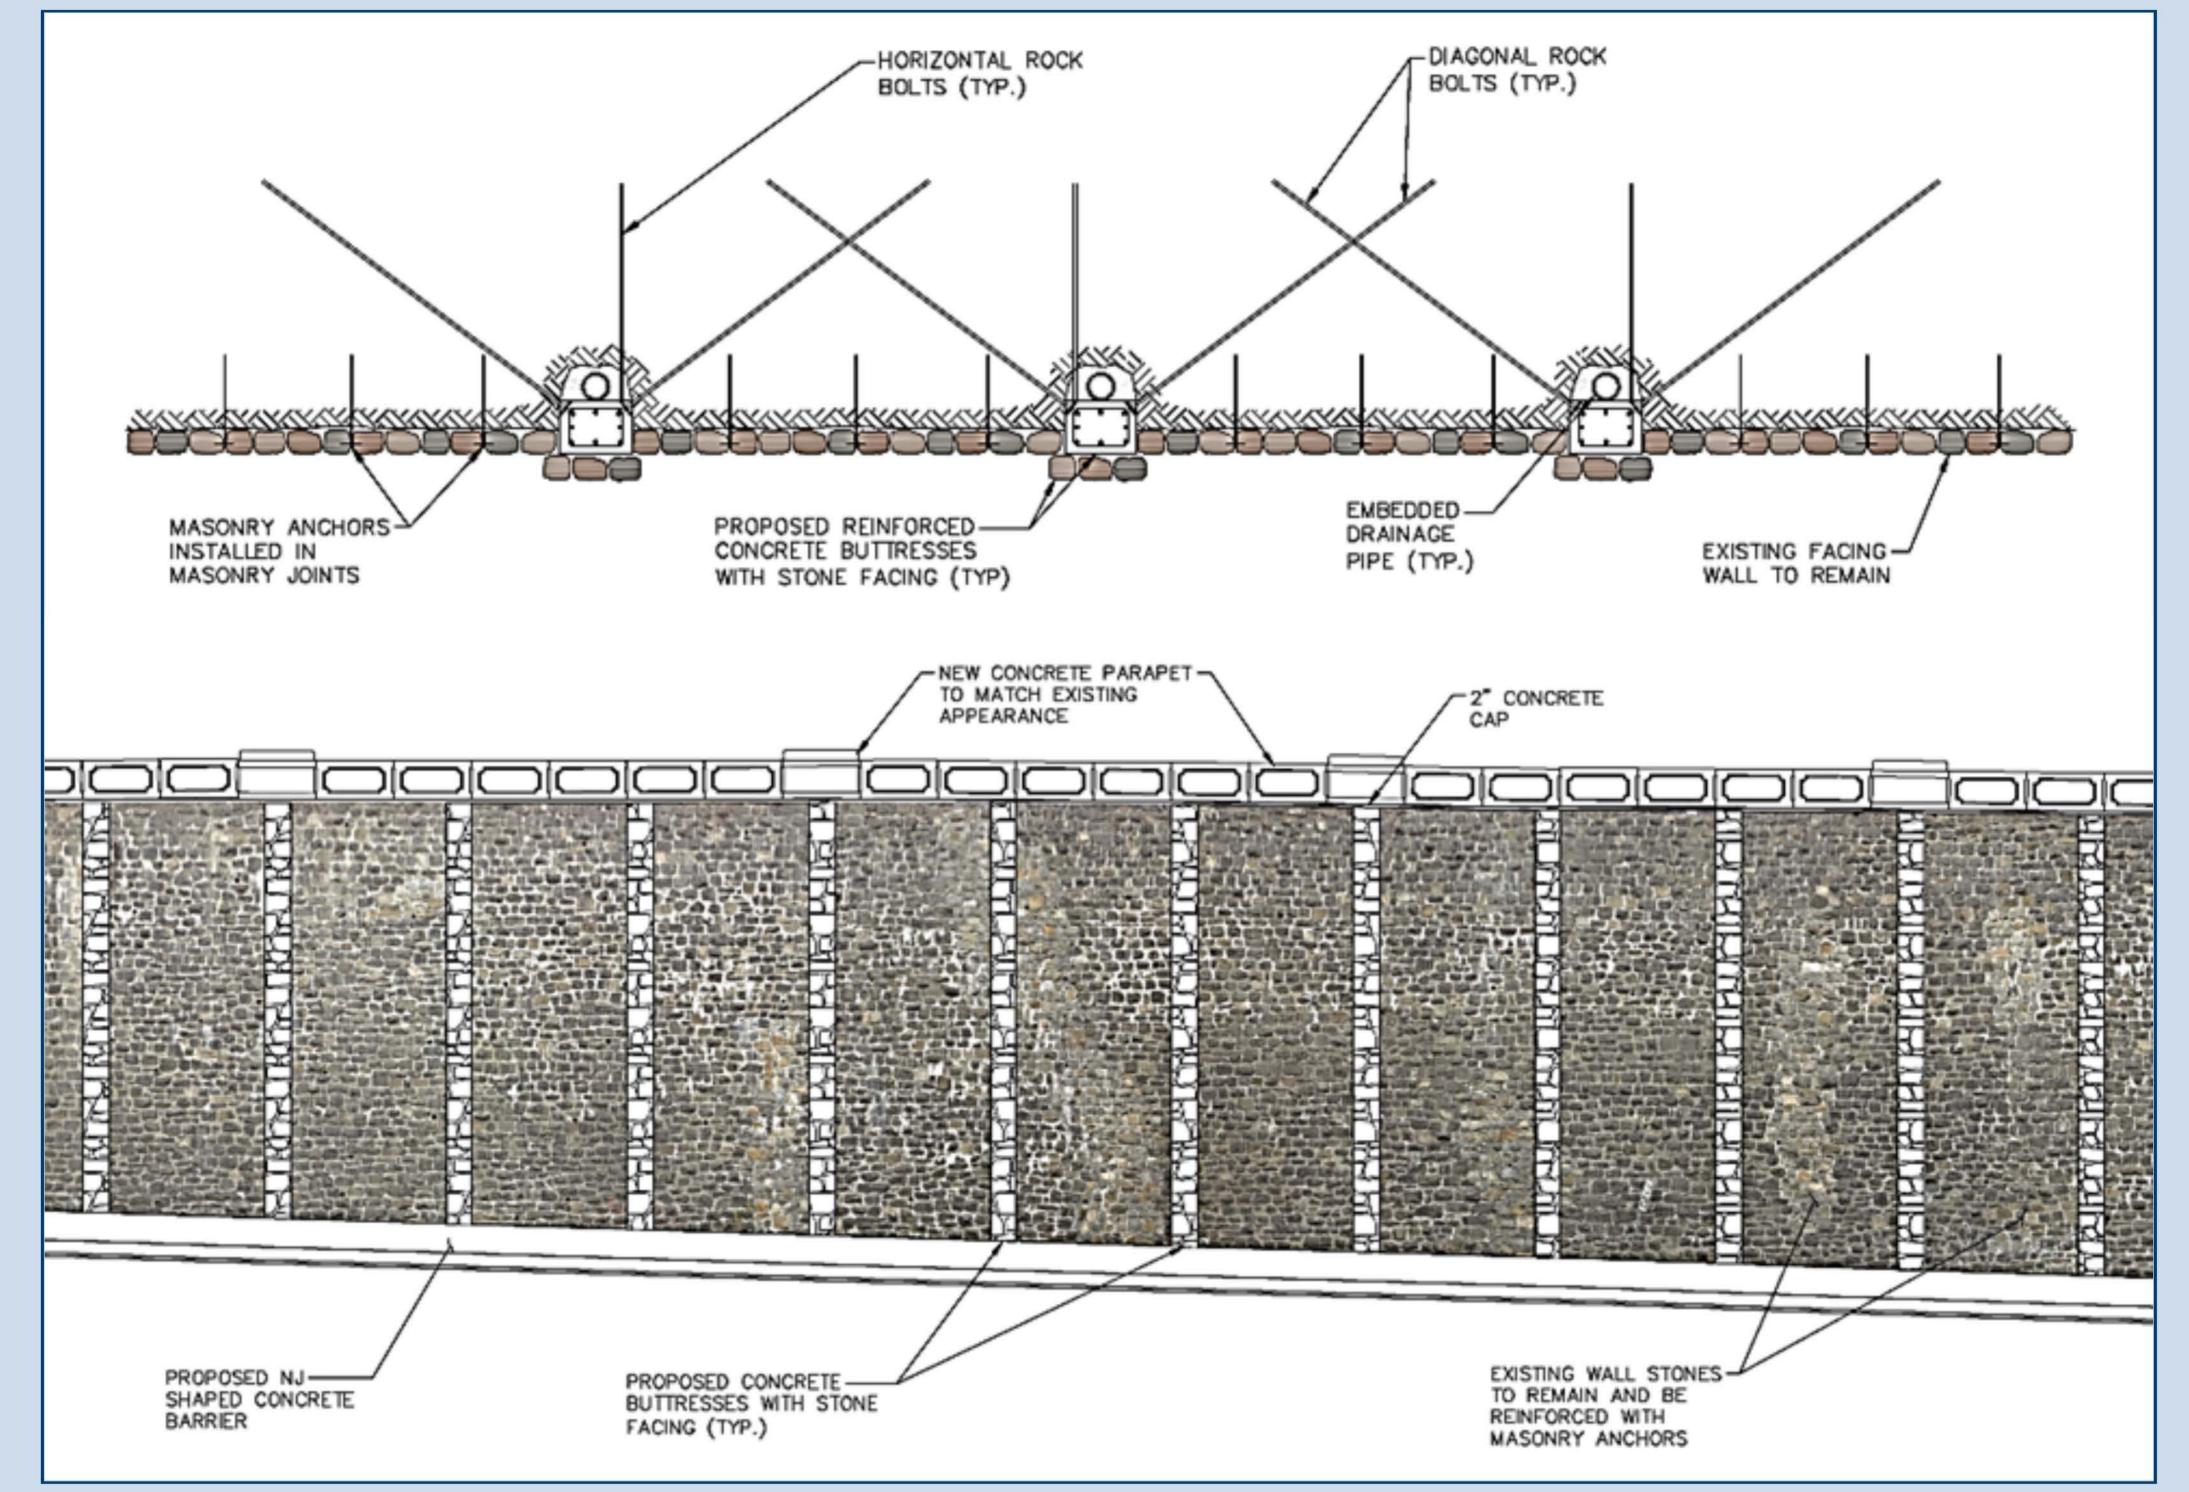
Repair Alternative #1B In Place Rehabilitation with Slope Stabilization

- Minimizes wall demolition.
- Reinforces the rock cliff behind the

existing wall to prevent fractures.

- Enables installation of new drainage system behind wall.
- Requires significant rock excavation to provide enough set-back for buttresses to avoid encroaching on roadway.

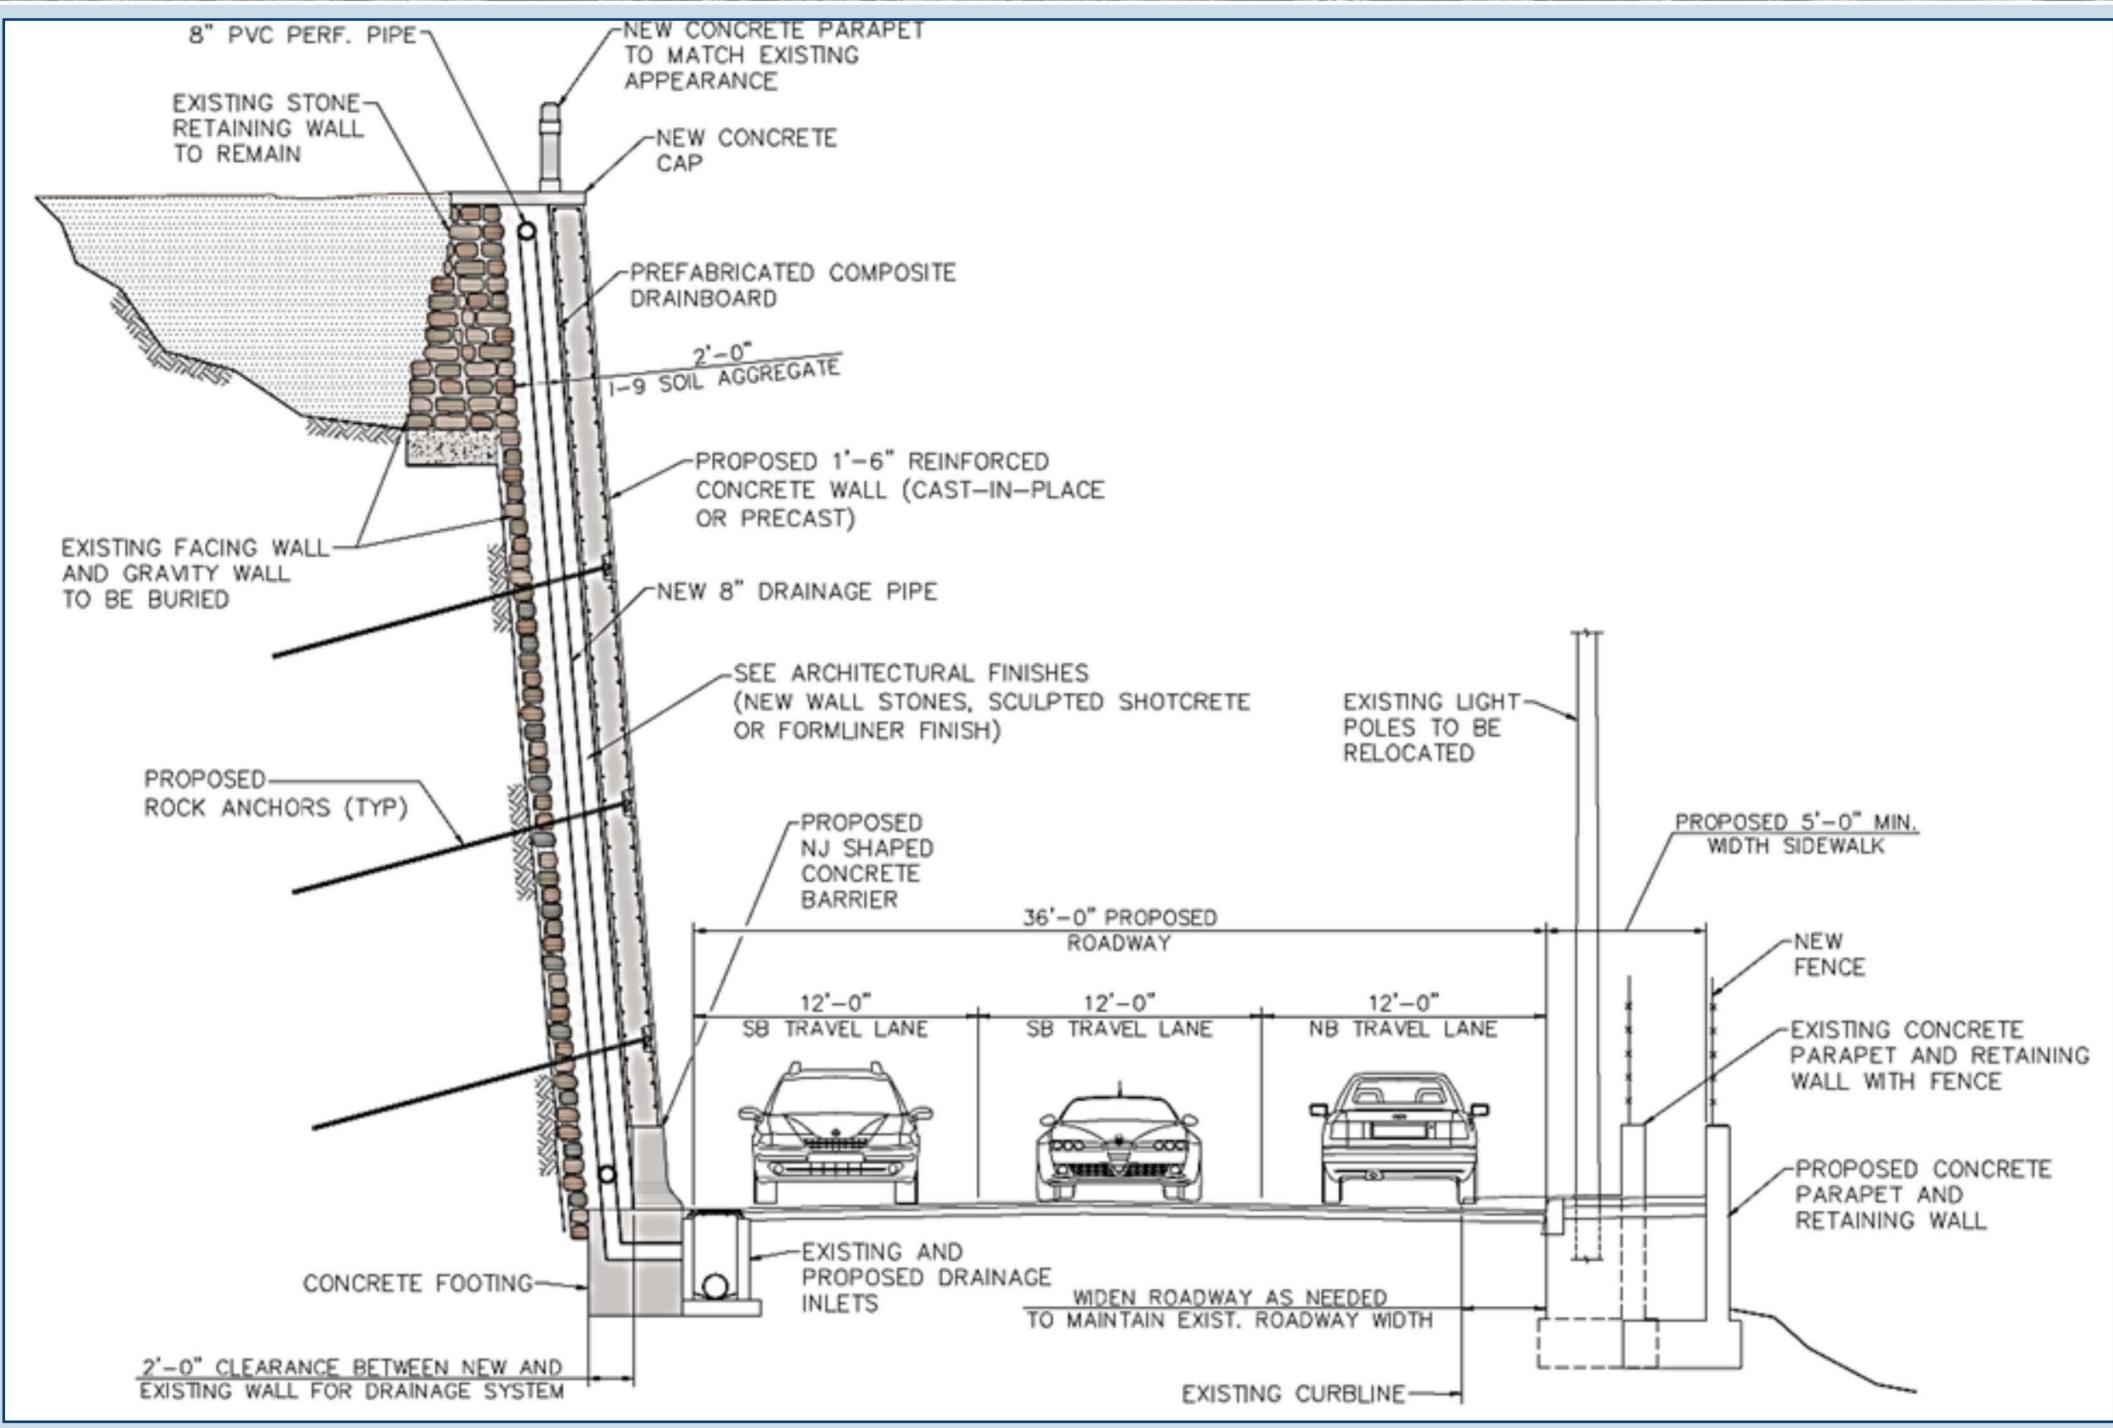
Repair Alternative #2 **Construct New Retaining Wall in Front of Existing Wall**

- Eliminates need wall for demolition & need for temporary retaining system.

- Requires roadway realignment and shift (to the east), to provide additional space for new wall.
- Does not maintain existing historic appearance of the walls.
- No impact to existing structures above the wall. Structures built on retained soil (parking lots, swimming pool, retaining walls etc.) can remain (if desired).
- Requires replacement of some of • the existing retaining walls on the east side of Manhattan Avenue.

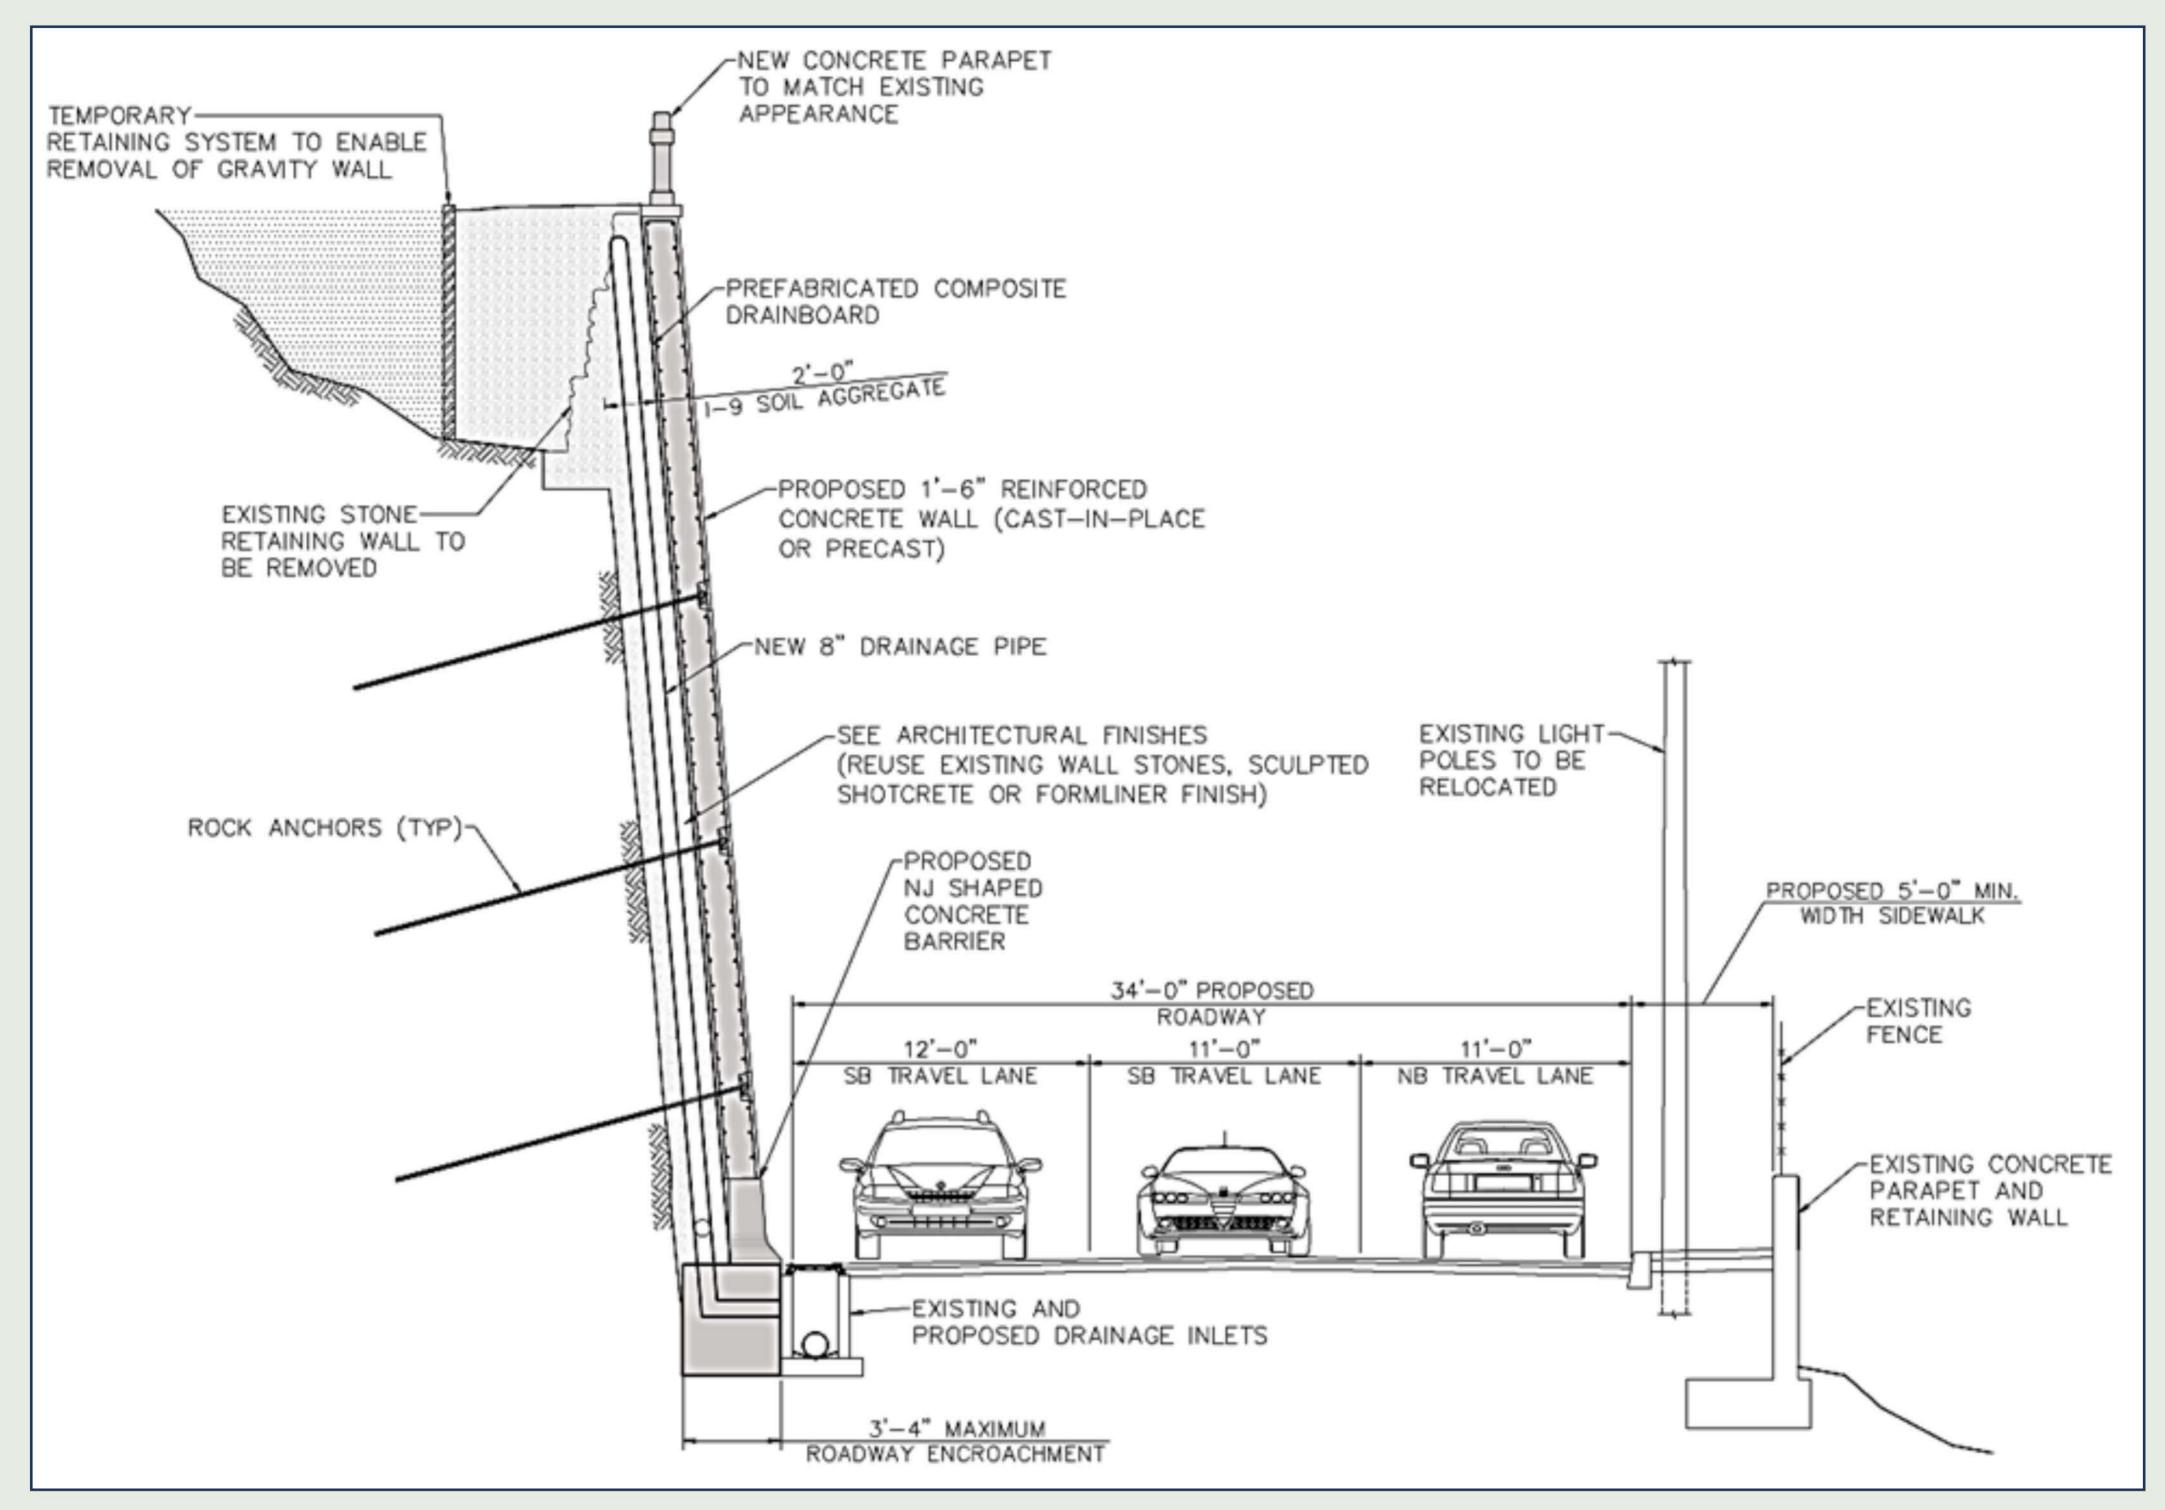
Repair Alternative #3 Remove & Replace Existing Retaining Wall

- Will impact existing structures above the wall that were built on
- Maintains existing alignment.
- Eliminates all hidden risks associated with the existing wall.
- Could reuse existing stones to maintain existing appearance.
- retained soil (parking lots, swimming pool, retaining walls etc.).

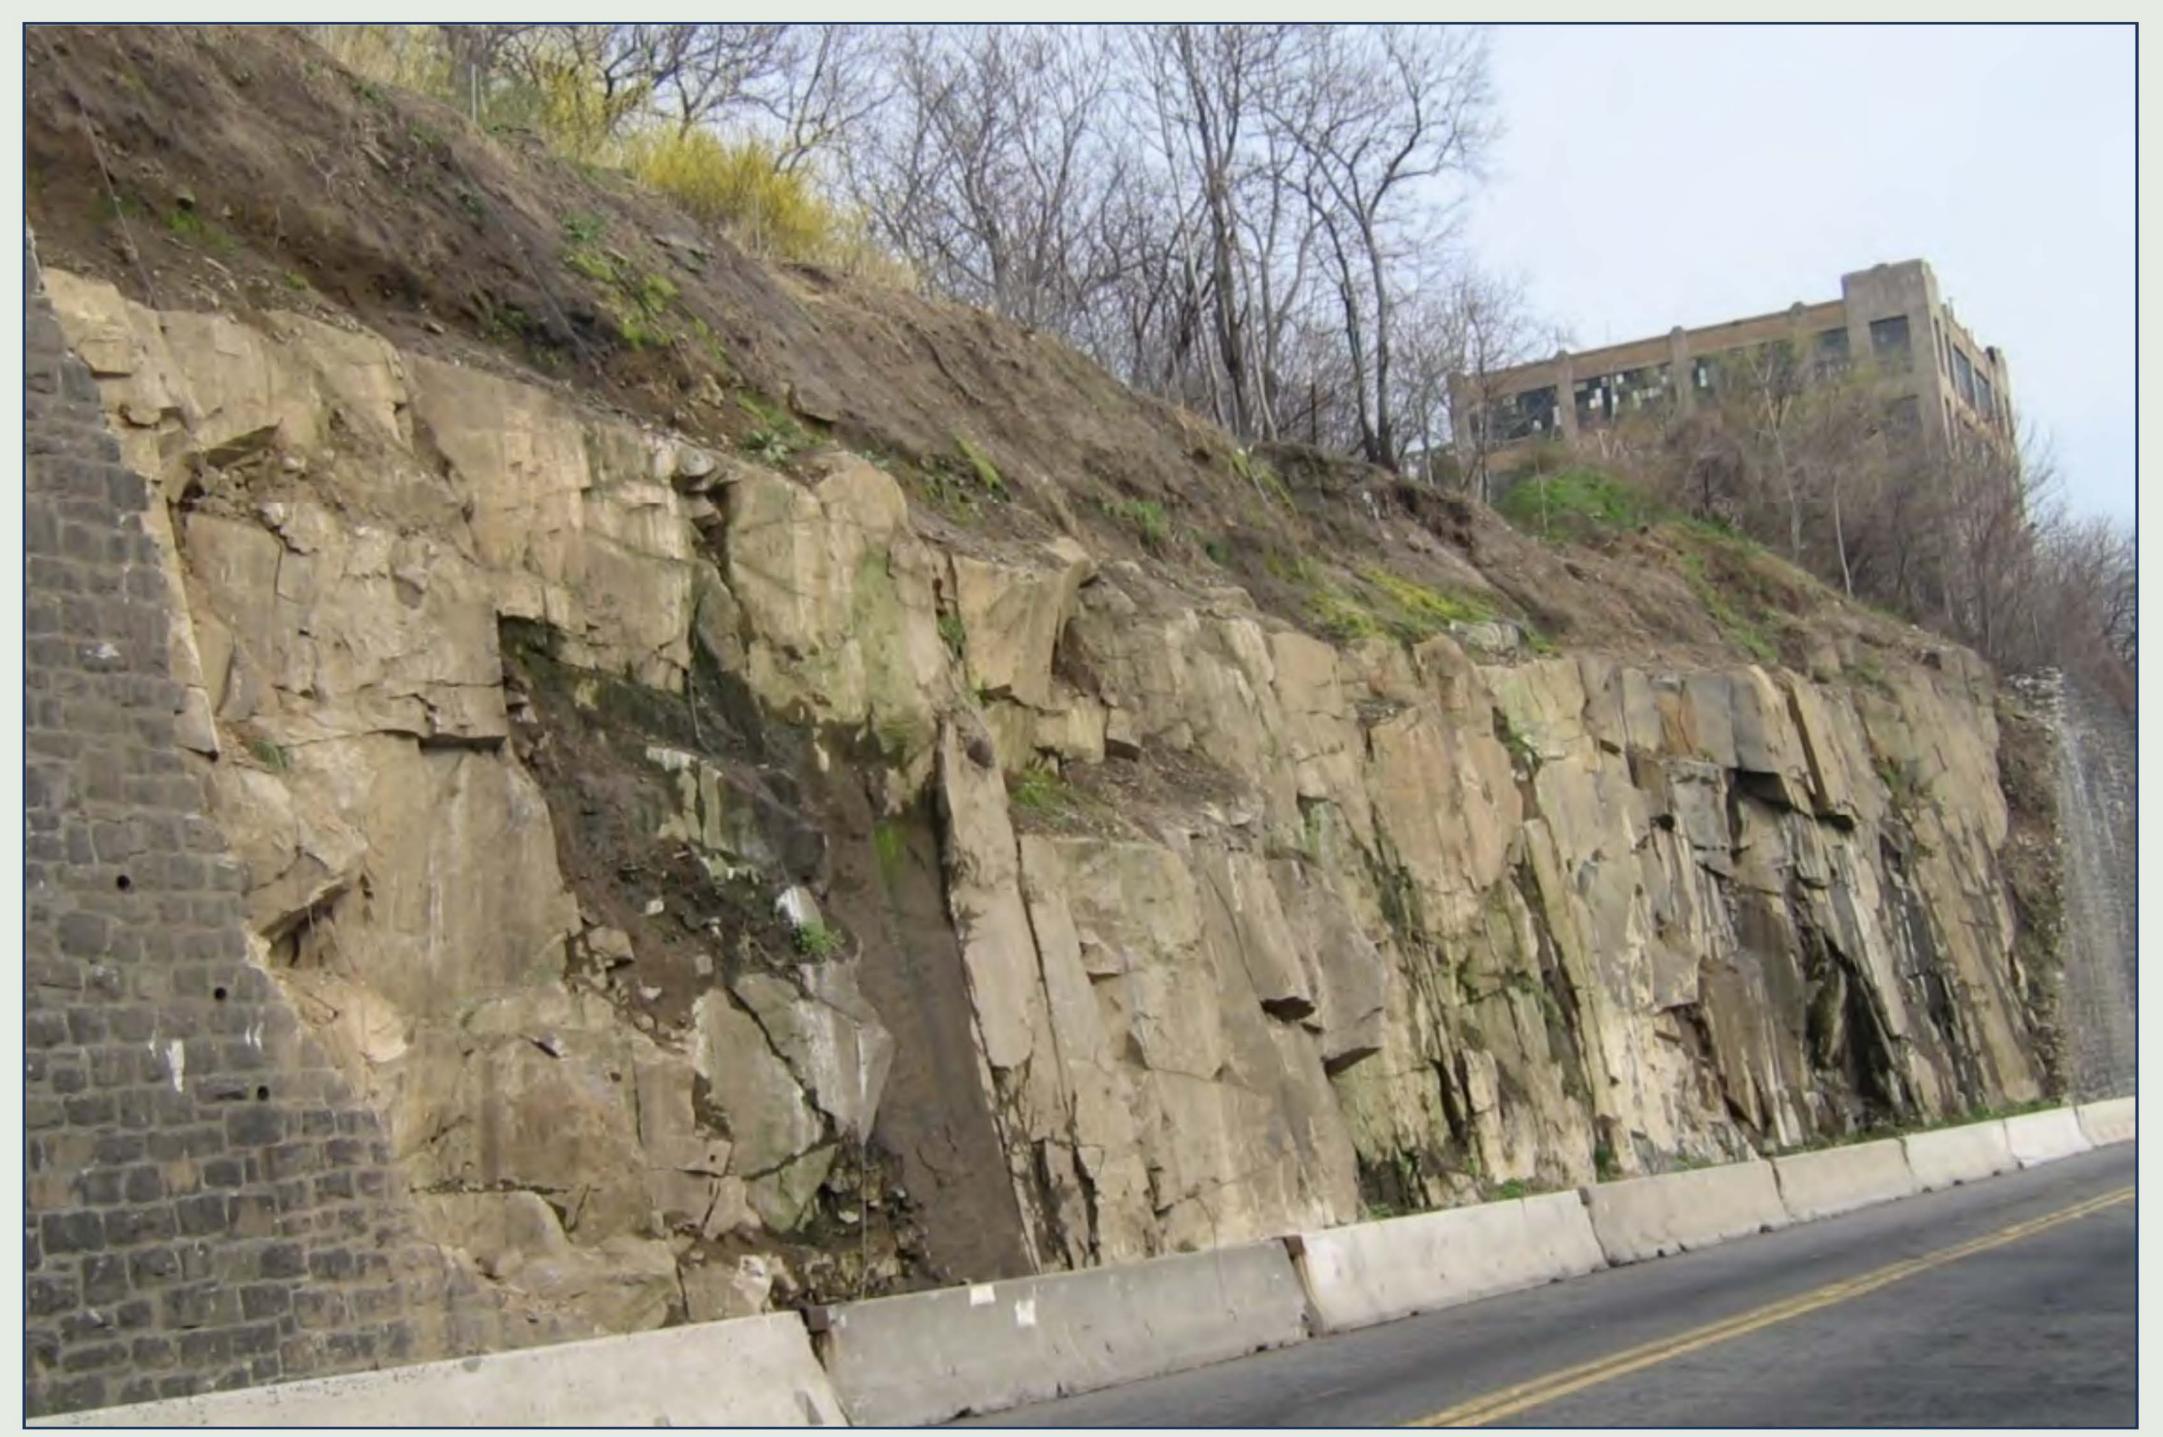
Repair Alternative #4 Remove the Existing Retaining Wall

• Eliminates the long term need for maintenance of the retaining wall.

- Impacts aesthetic appearance.
- Unknown profile of rock face behind wall.
- Risk of encountering unknown conditions once demolition work begins. May require additional work to stabilize exposed rock face.

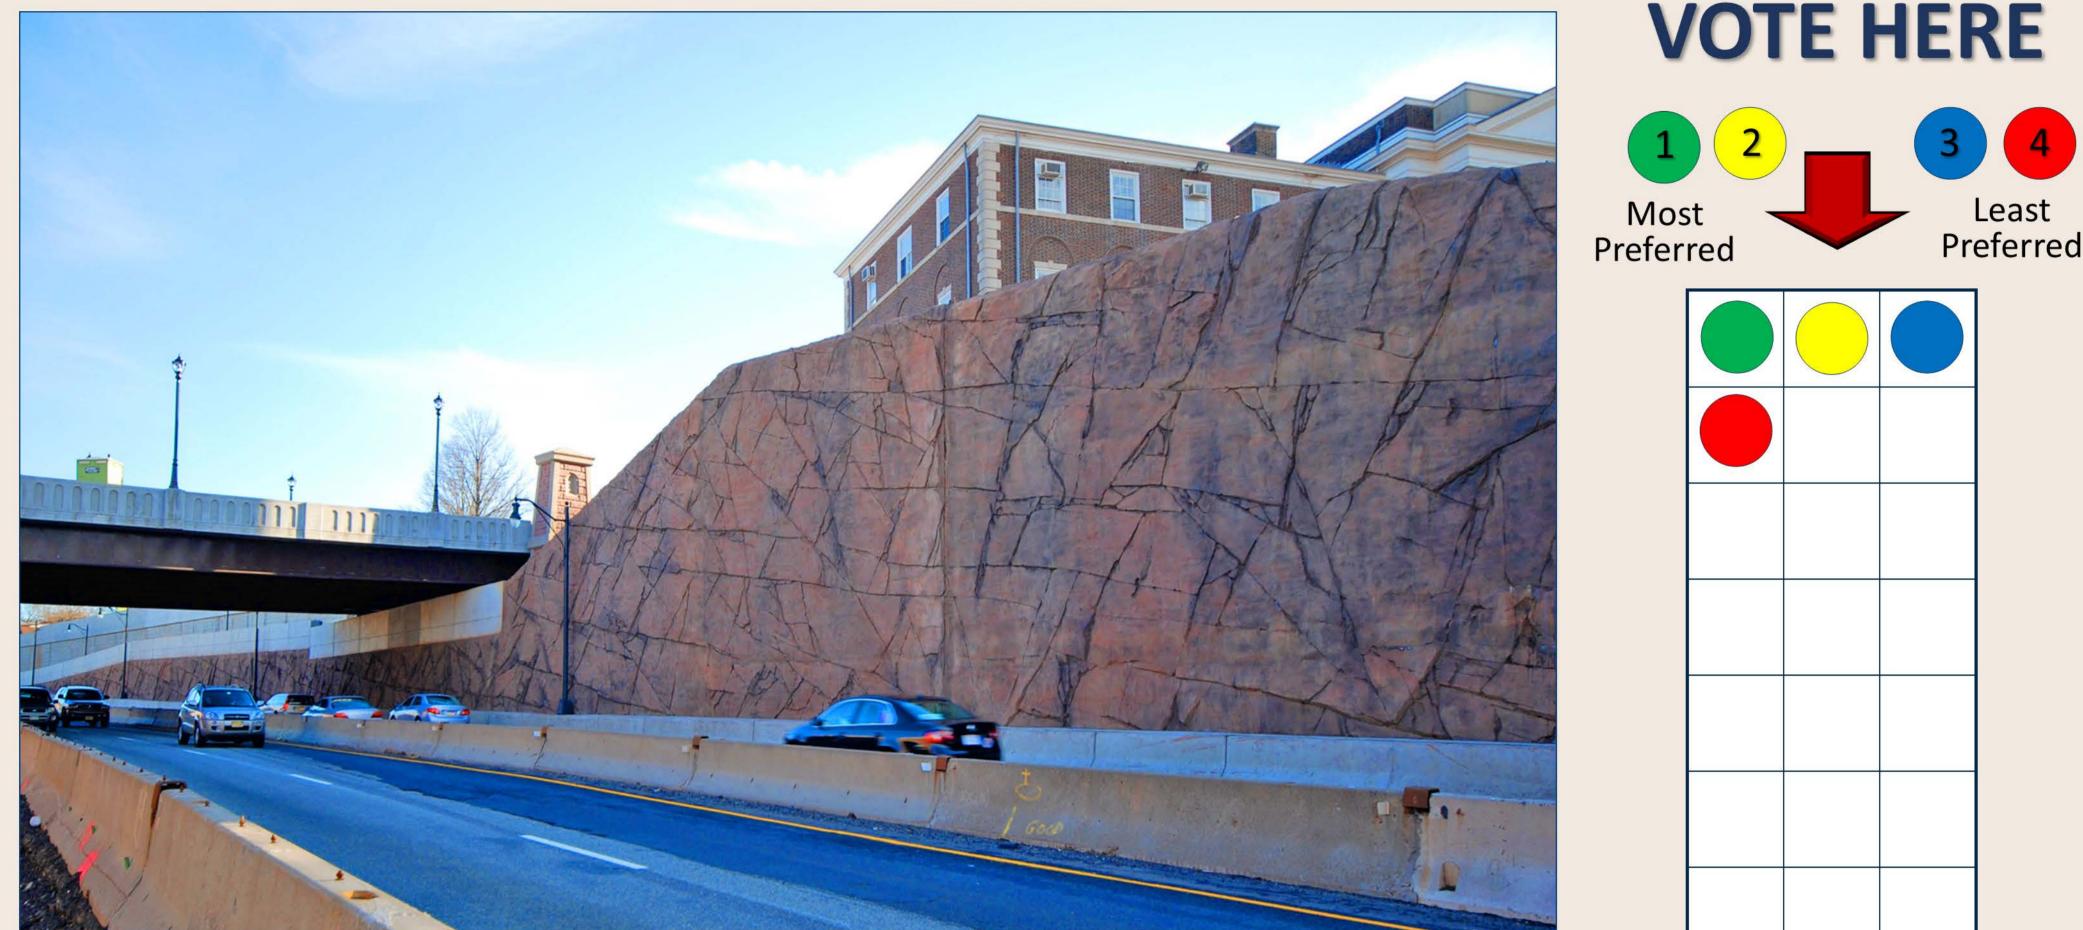
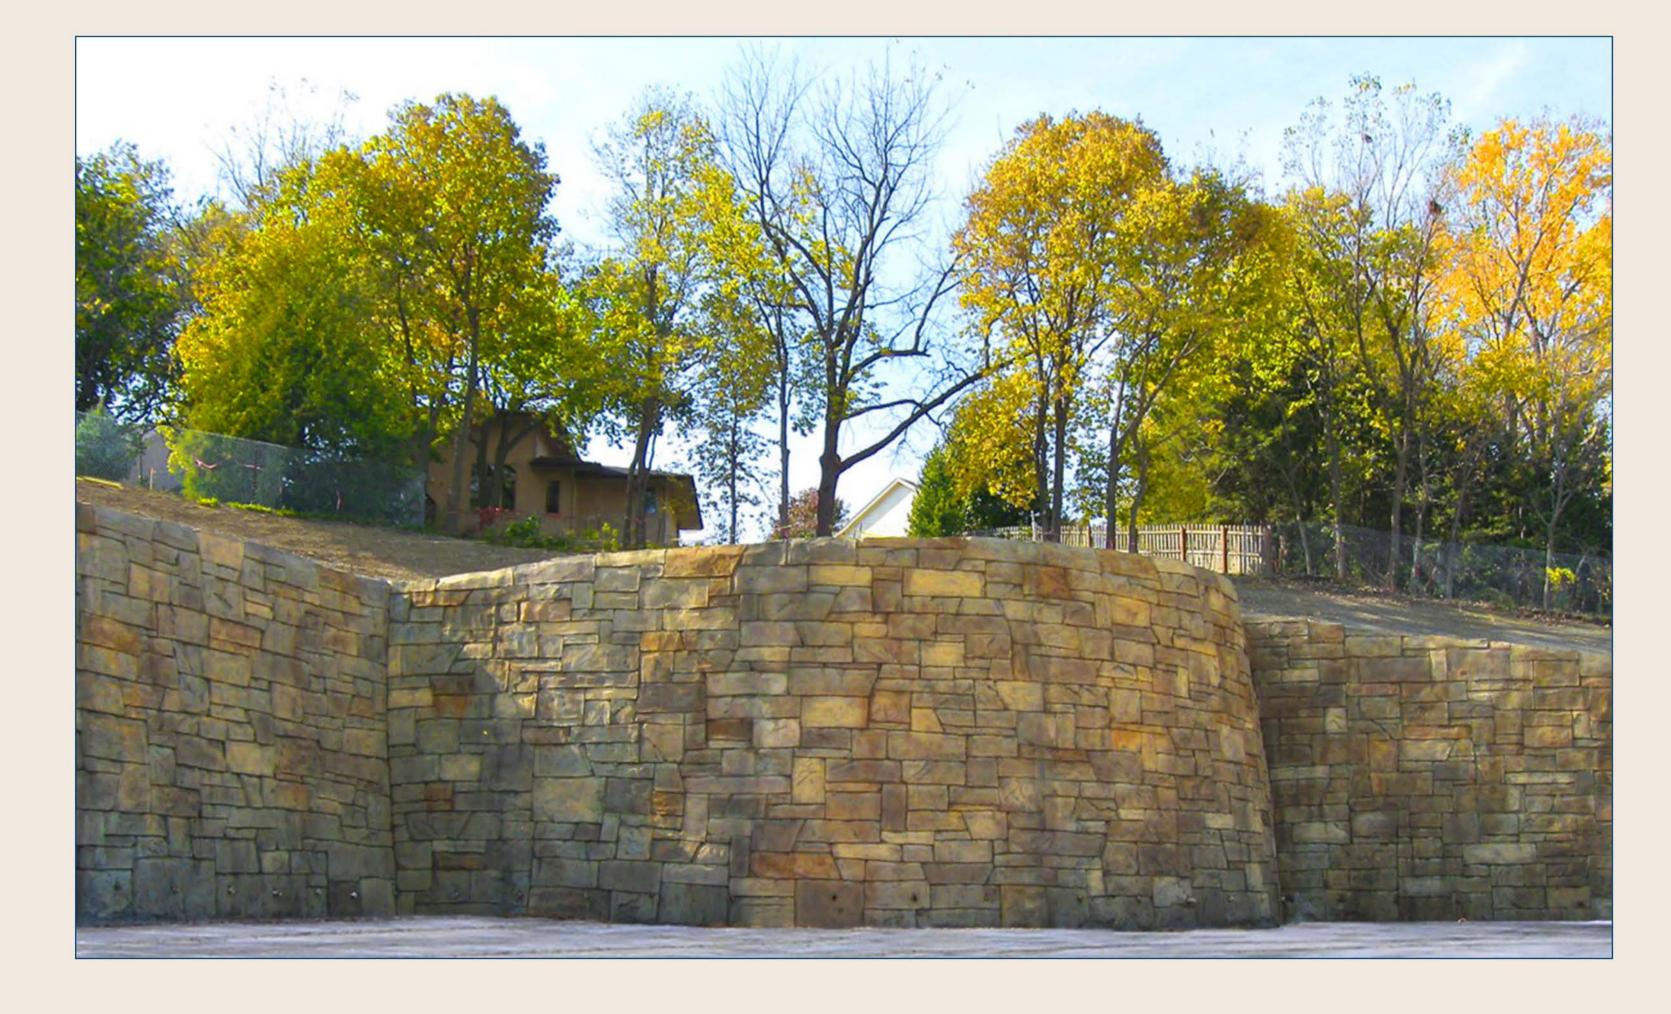
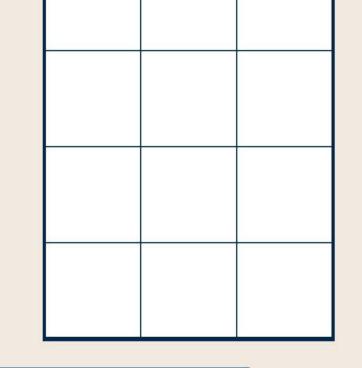
Architectural Finish Alternative #1

Hand Sculpted and Stained Shotcrete

Sample sculpted shotcrete finishes. Masonry patterns are hand carved and can be customized to replicate the existing look of the Manhattan Avenue Retaining Walls (See sample bottom photo).

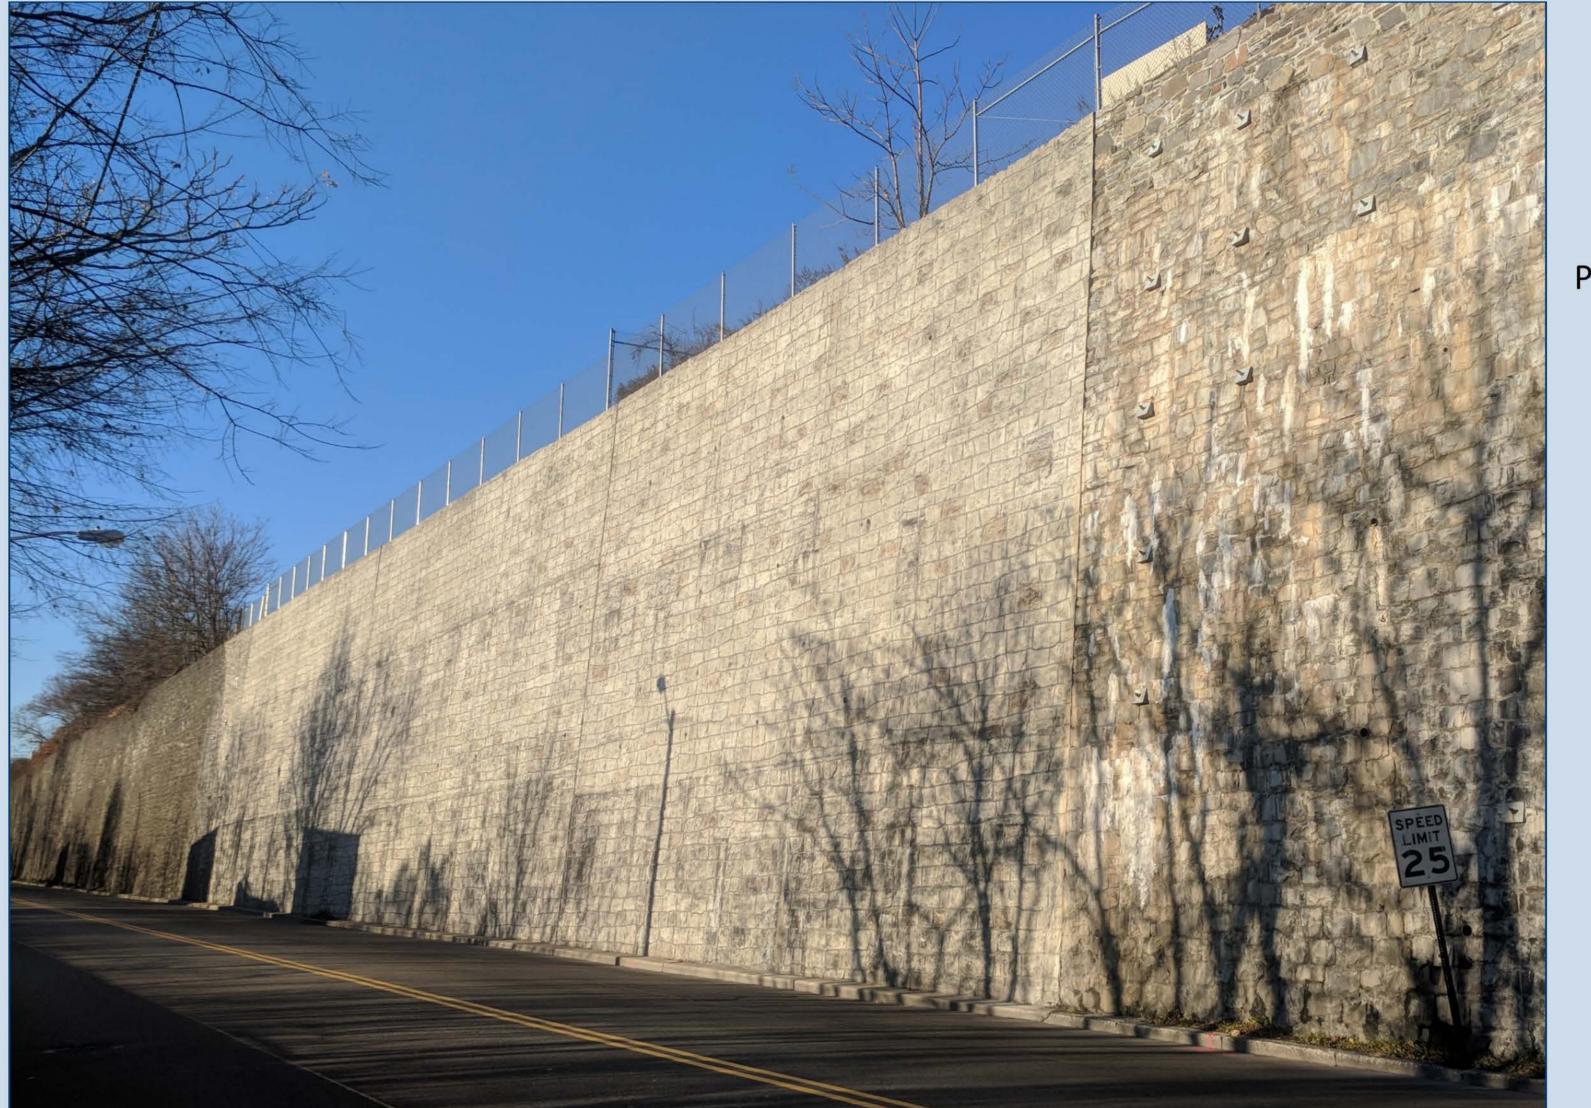
Architectural Finish Alternative #2

Decorative Concrete Formliner
