FY 2017 Hudson, Morris, & Somerset Counties Local Concept Development Studies Contract "B"

Retaining Wall & Slope Stabilization Improvements Along Manhattan Avenue

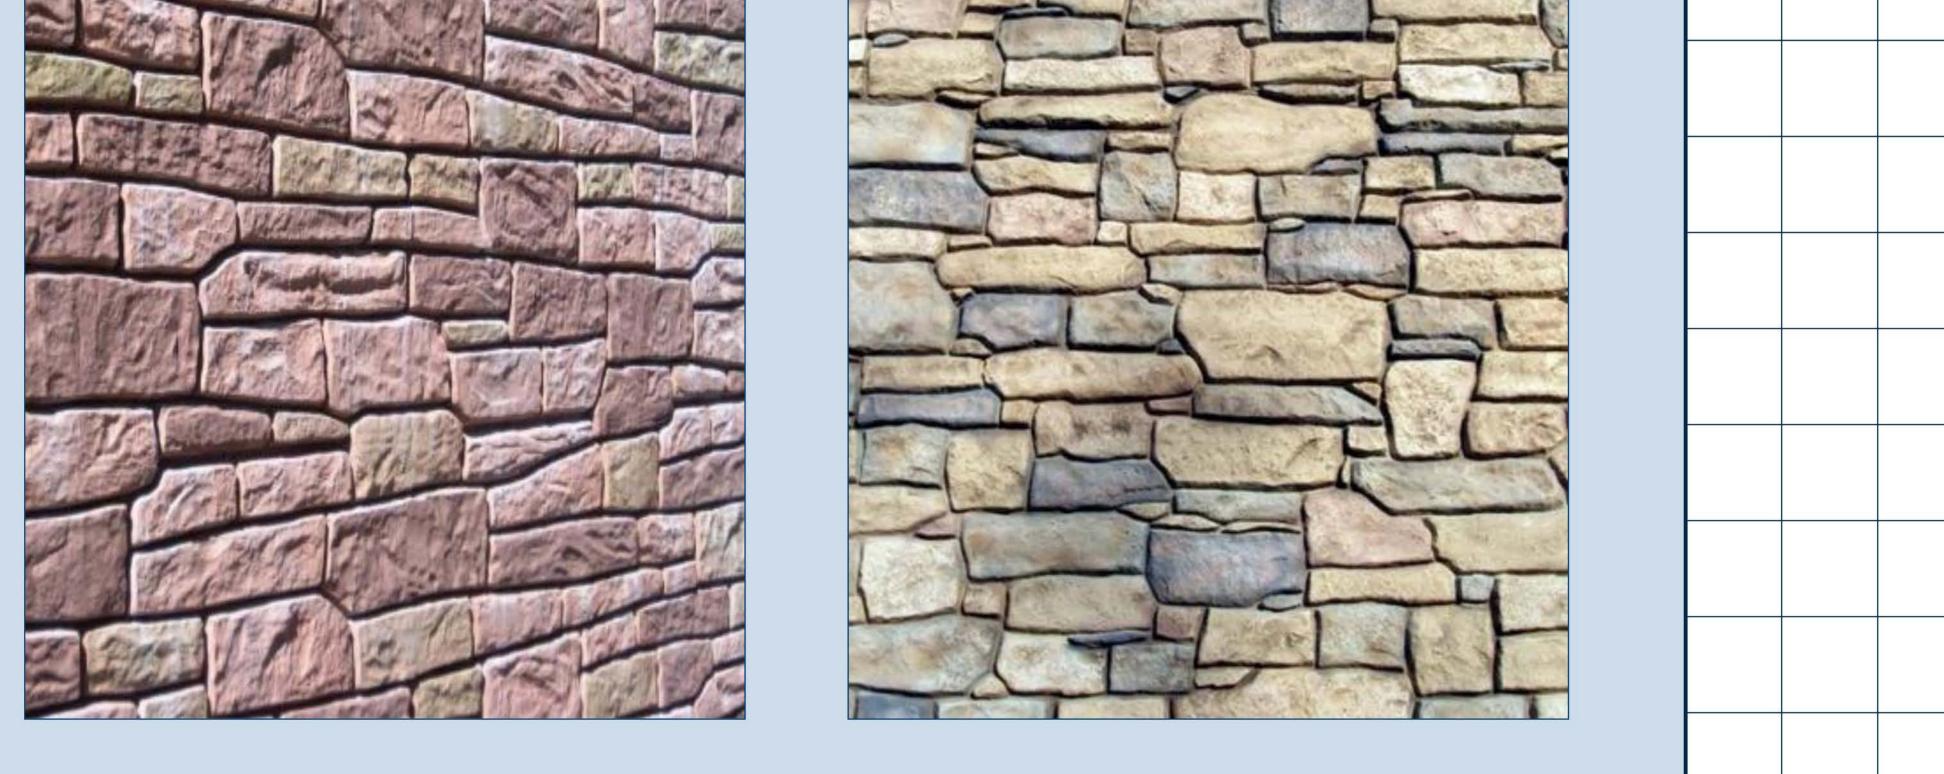
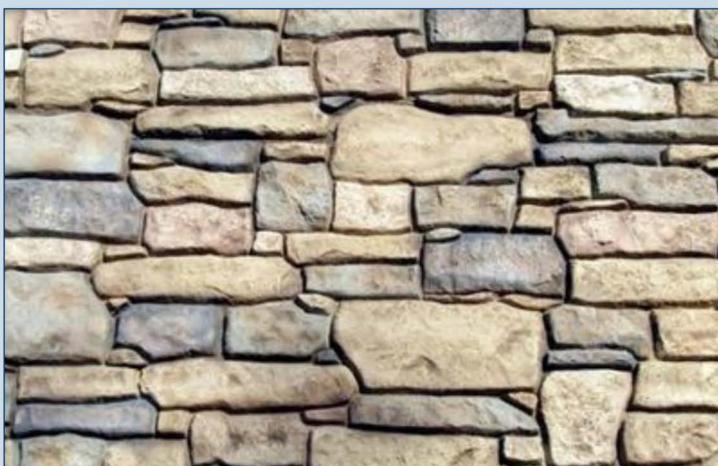
South Wall Replacement Following 2007 Collapse—Formlined, But Not Stained

Sample decorative concrete formliner finishes. The 2008 repair utilized this type of wall system, but the concrete was not stained. Staining the concrete could help make it blend in with the adjacent stone masonry.

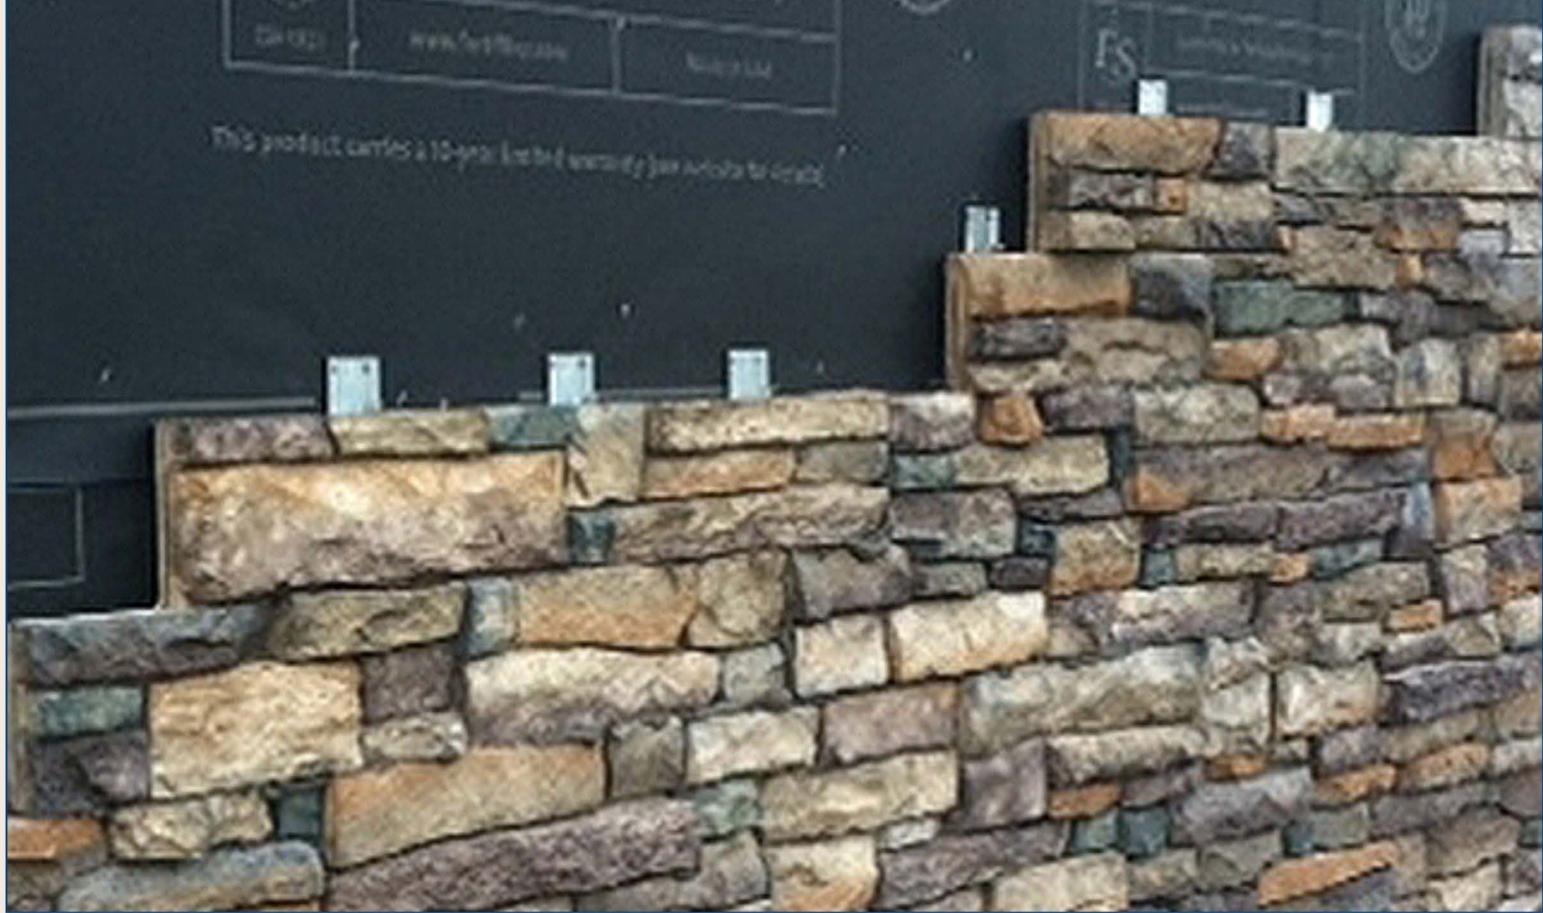
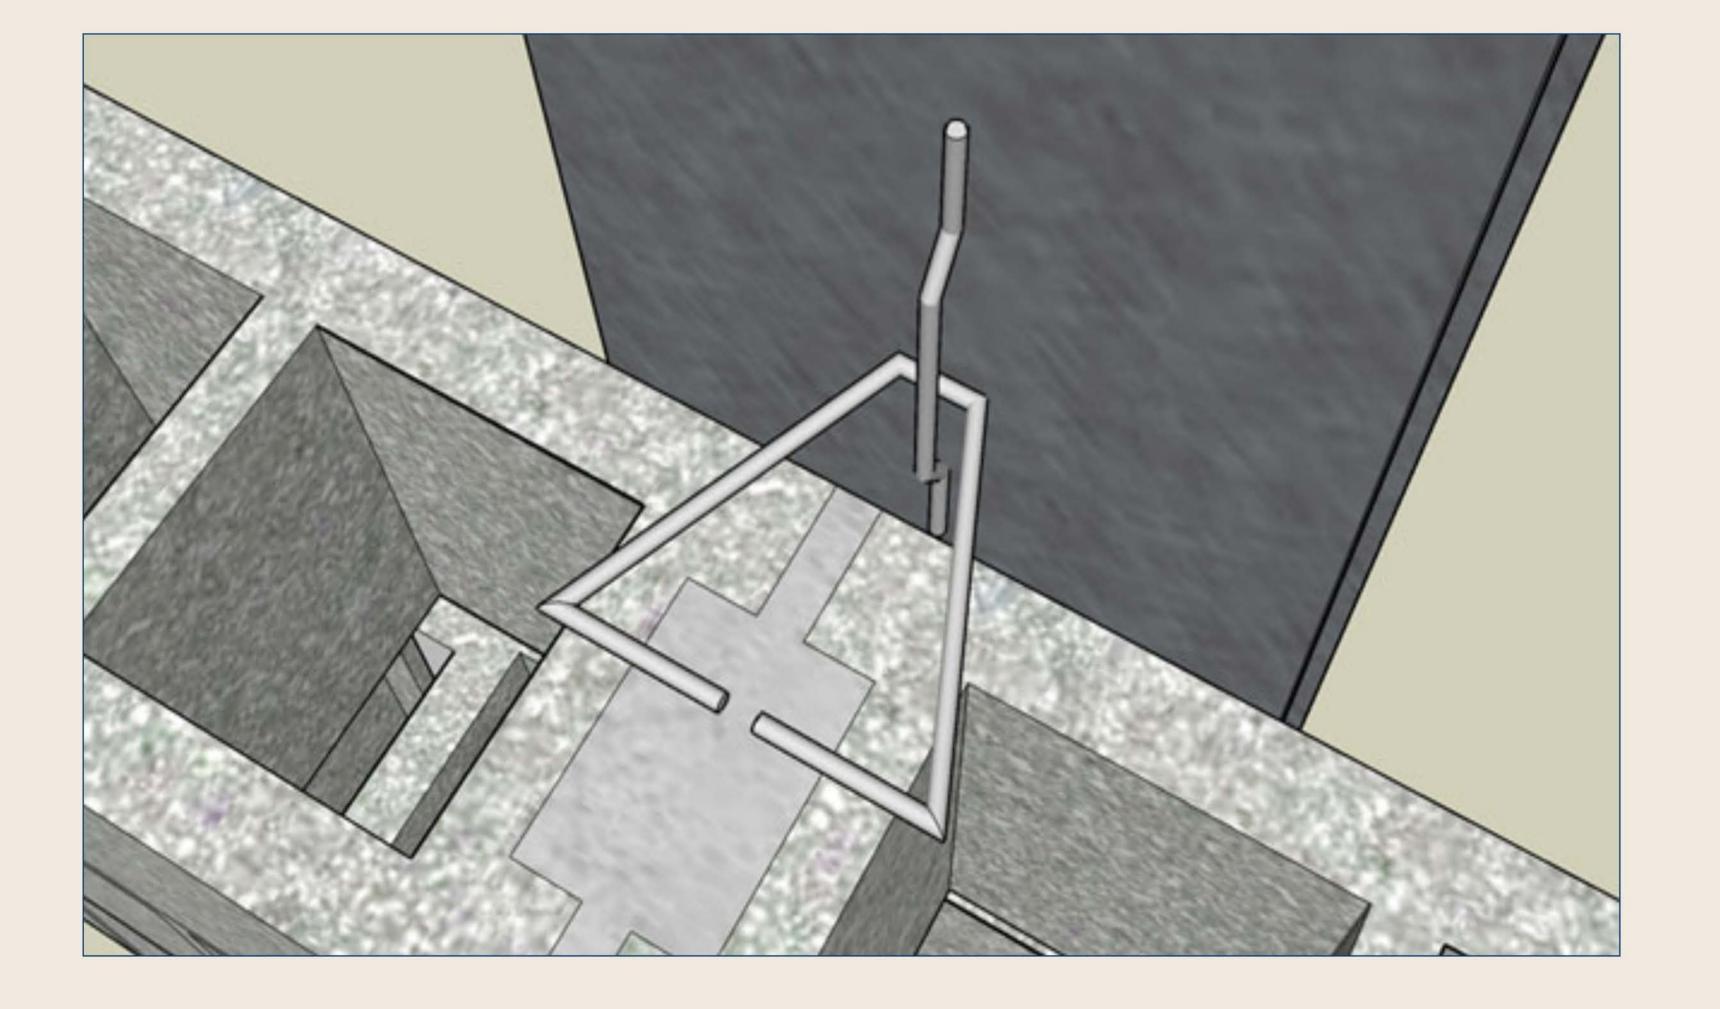
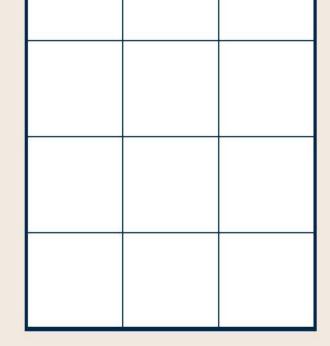
Architectural Finish Alternative #3

New 6" Stone Veneer

Typical masonry anchors. The proposed stone veneer would be anchored to the concrete backing wall with dovetail anchors to secure the stones in place and prevent them breaking loose.

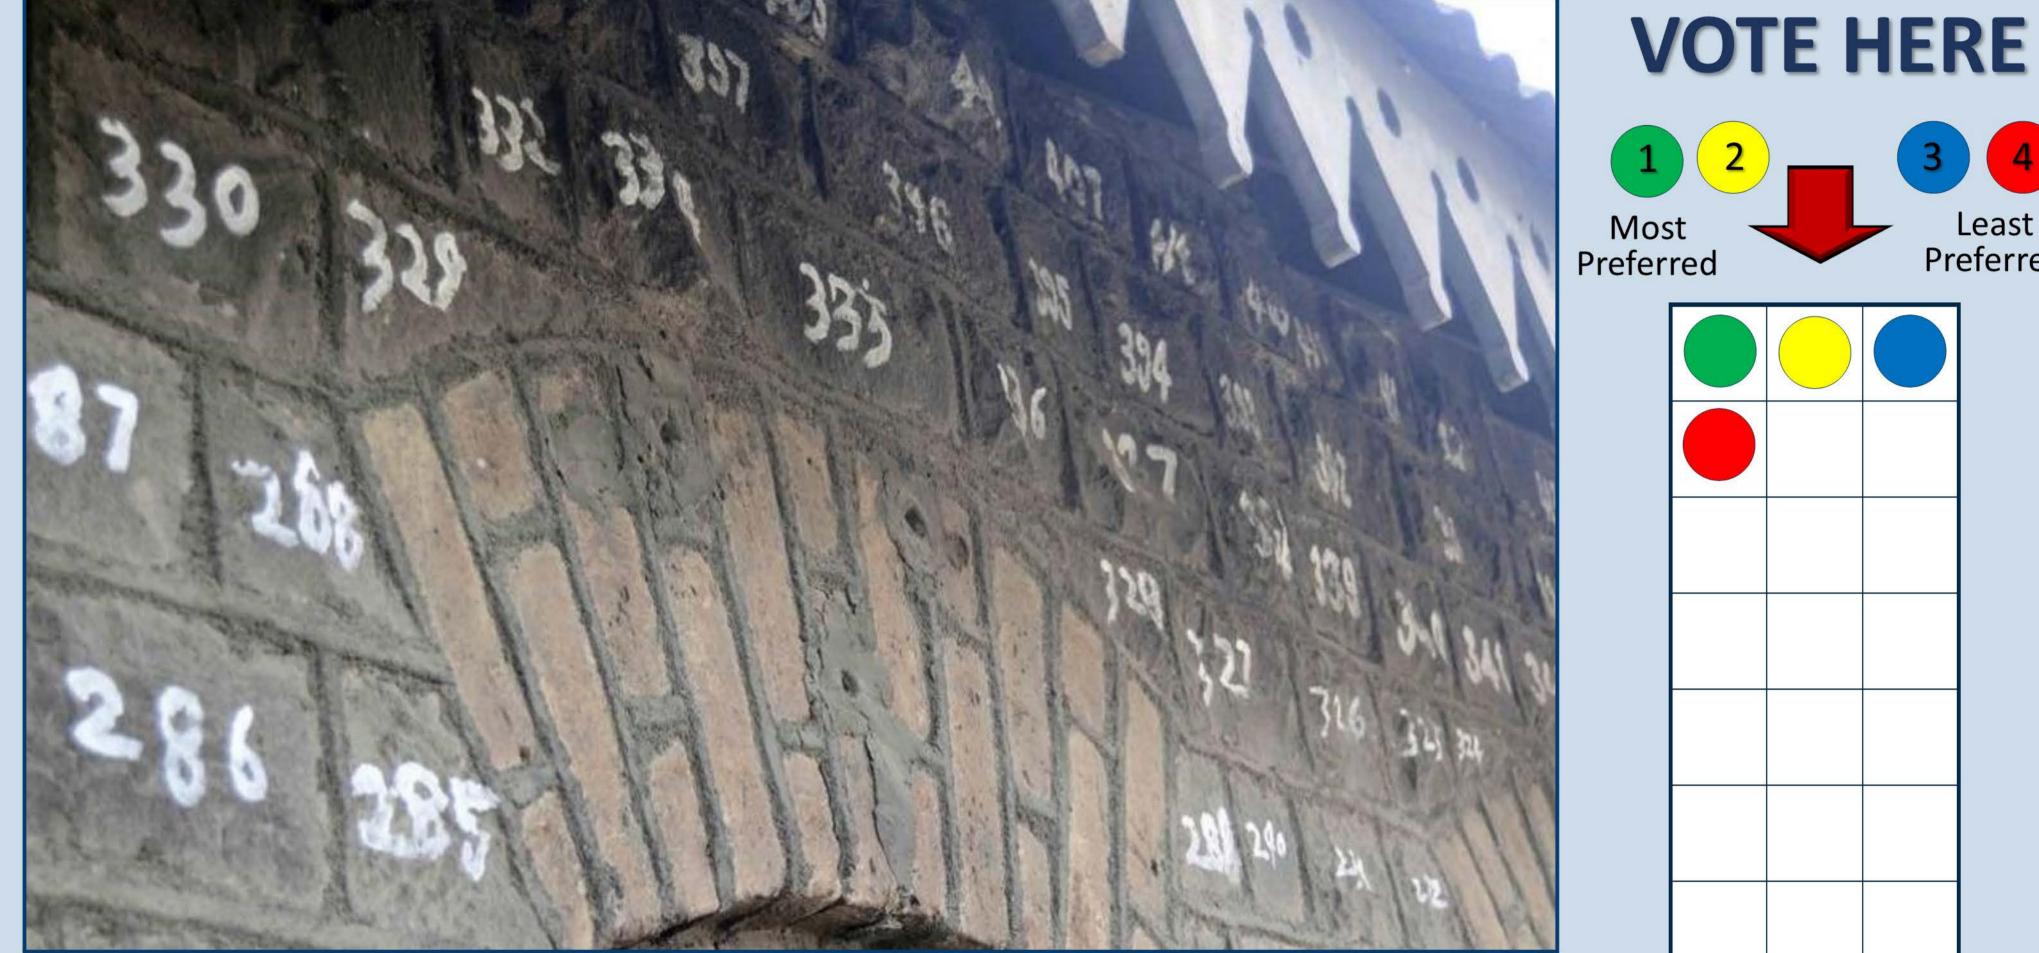
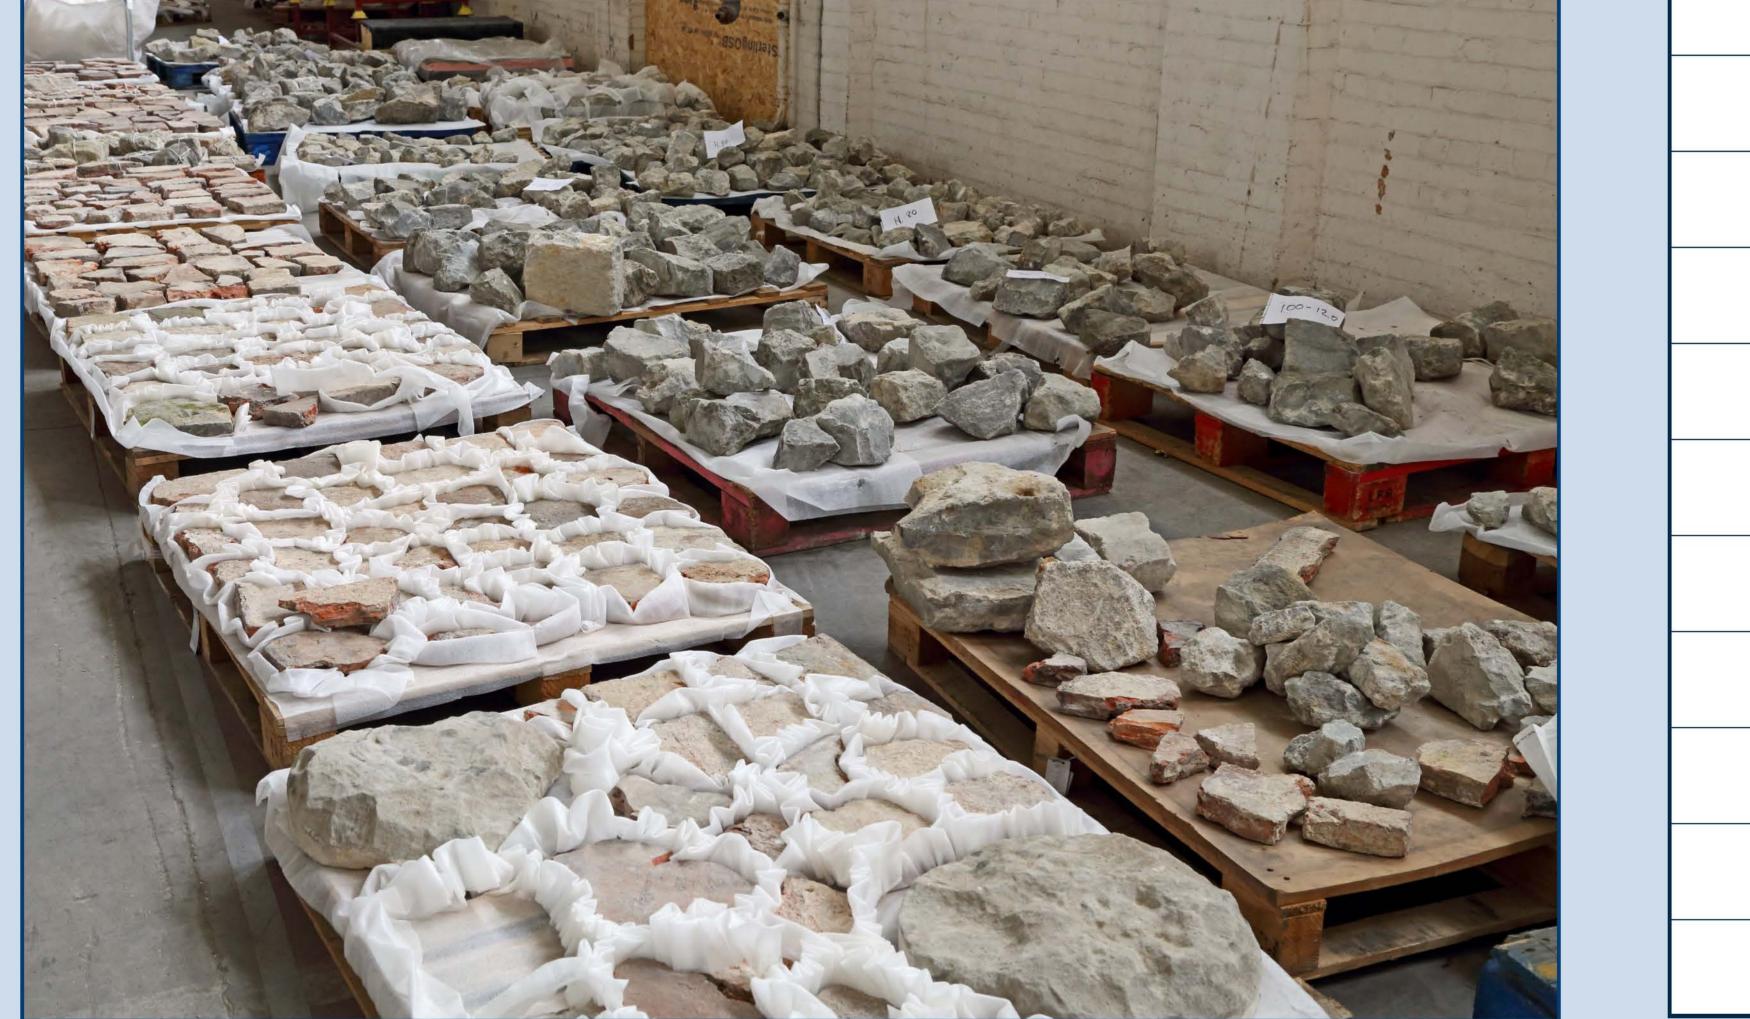
Architectural Finish Alternative #4

Number, Dismantle and Reuse Existing Stones

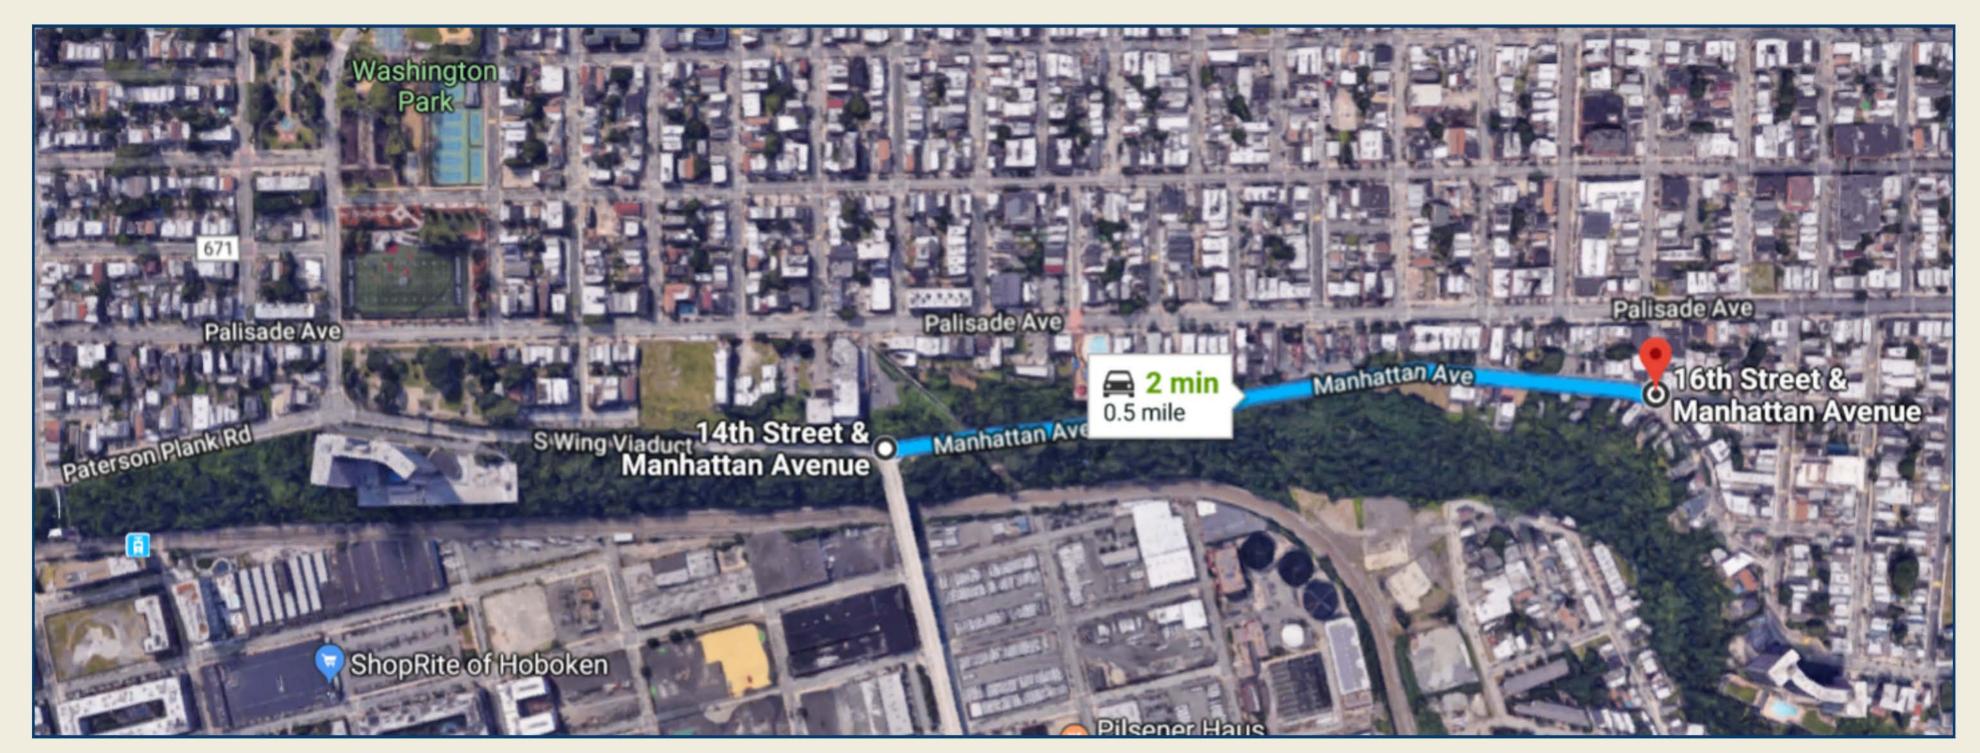
14th Street Viaduct to 16th Street - Existing Route Travel Time and Distance

Travel Distance	Travel Time (w/o Traffic)
Existing Roadway	0.5 miles	2 minutes
Proposed Detour Route	1.2 miles	5 to 7 minutes
Net Increase	0.7 mile	3 to 5 minutes

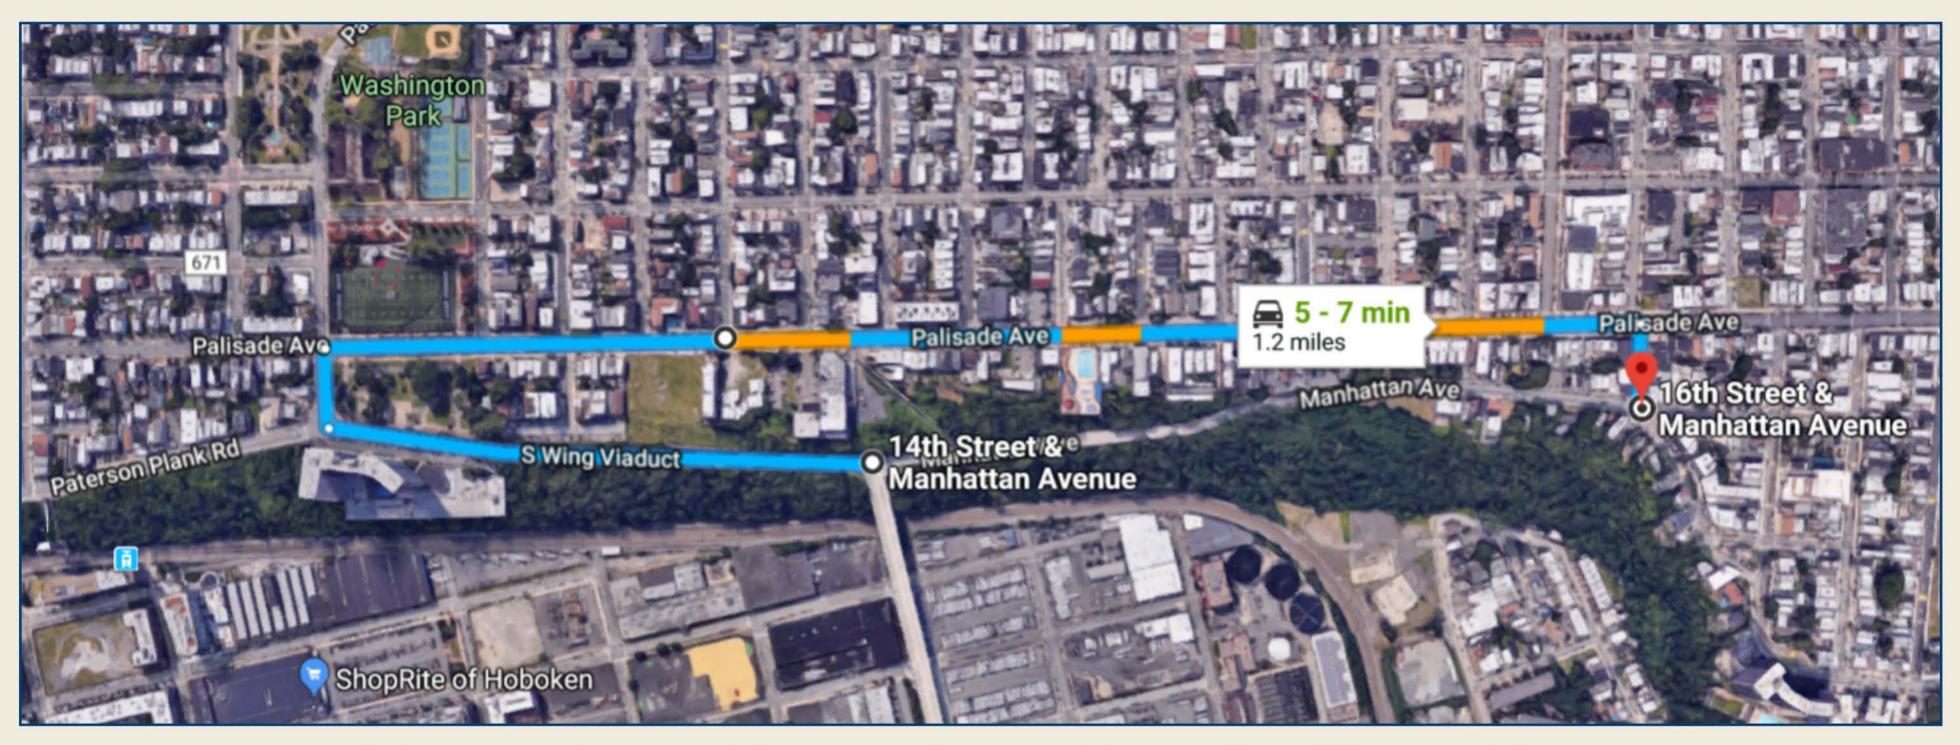
14th Street Viaduct to 16th Street - Proposed Detour Travel Time and Distance

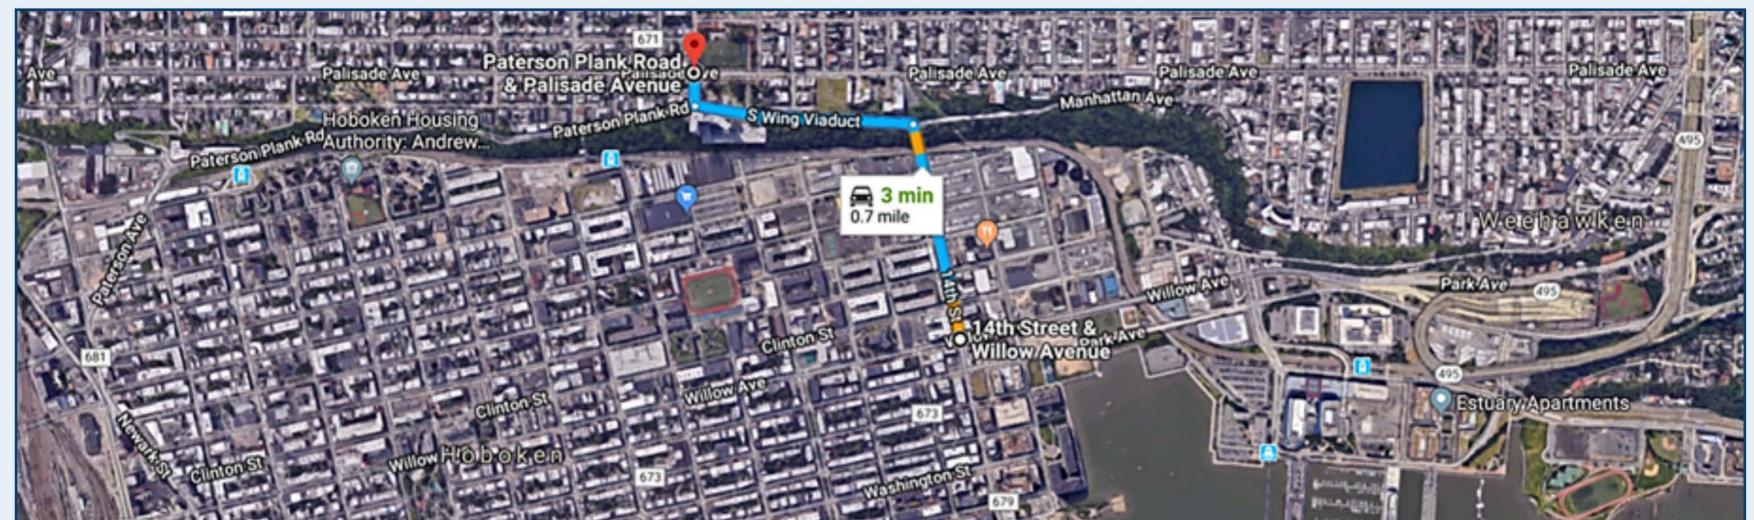
14th Street Viaduct to Paterson Plank Road - Existing Route Travel Time and Distance

Travel Distance	Travel Time (w/o Traffic)
Existing Roadway	0.7 miles	3 minutes
Proposed Detour Routes	2.6 / 2.7 miles	9-12 / 10-16 minutes
Net Increase	1.9 / 2.0 miles	6-9 / 7-13 minutes

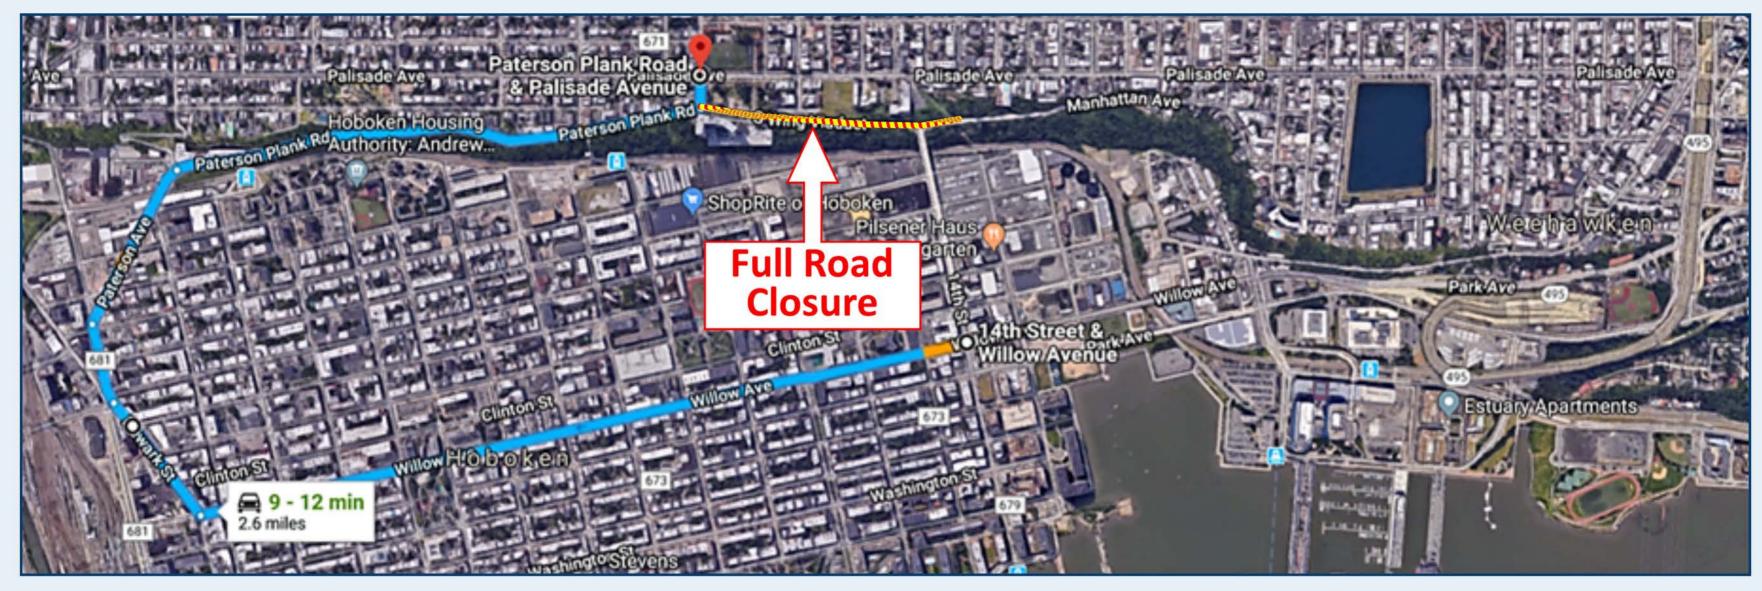
14th Street Viaduct to Paterson Plank Road - Proposed Southern Detour

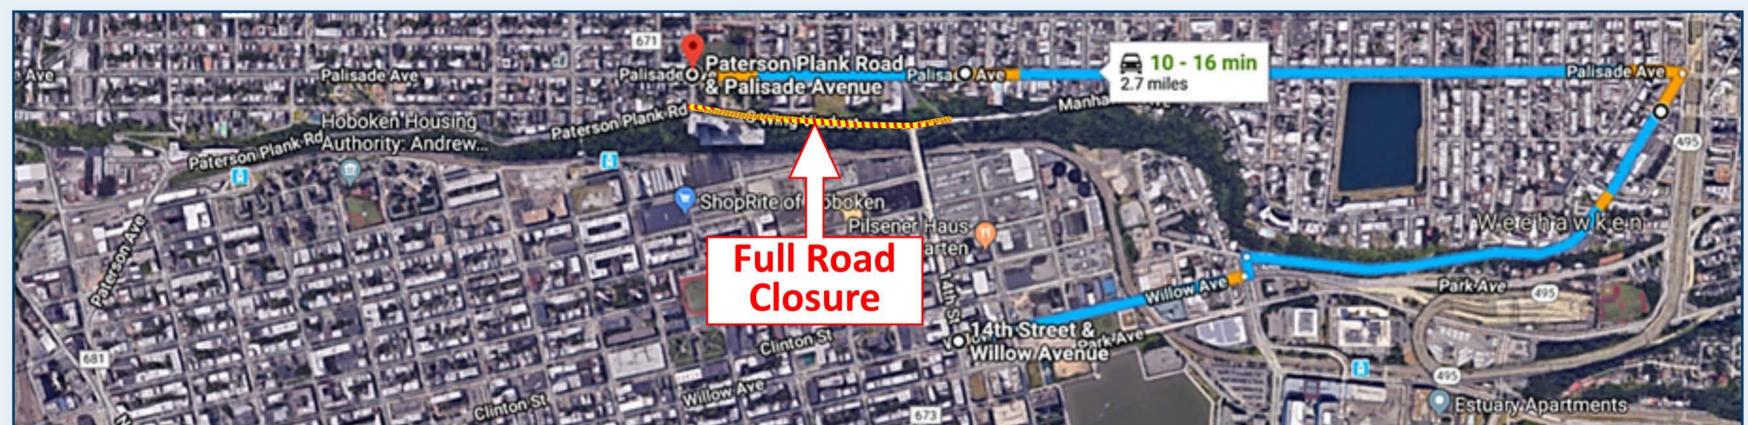
14th Street Viaduct to Paterson Plank Road - Proposed Northern Detour
